**ZIONSVILLE WASTEWATER DEPARTMENT
10-YEAR SEWER REHABILITATION REPORT
2013 - 2022**

Town of Zionsville, Indiana

December 19, 2012

**BLN JOB NO.
101041**

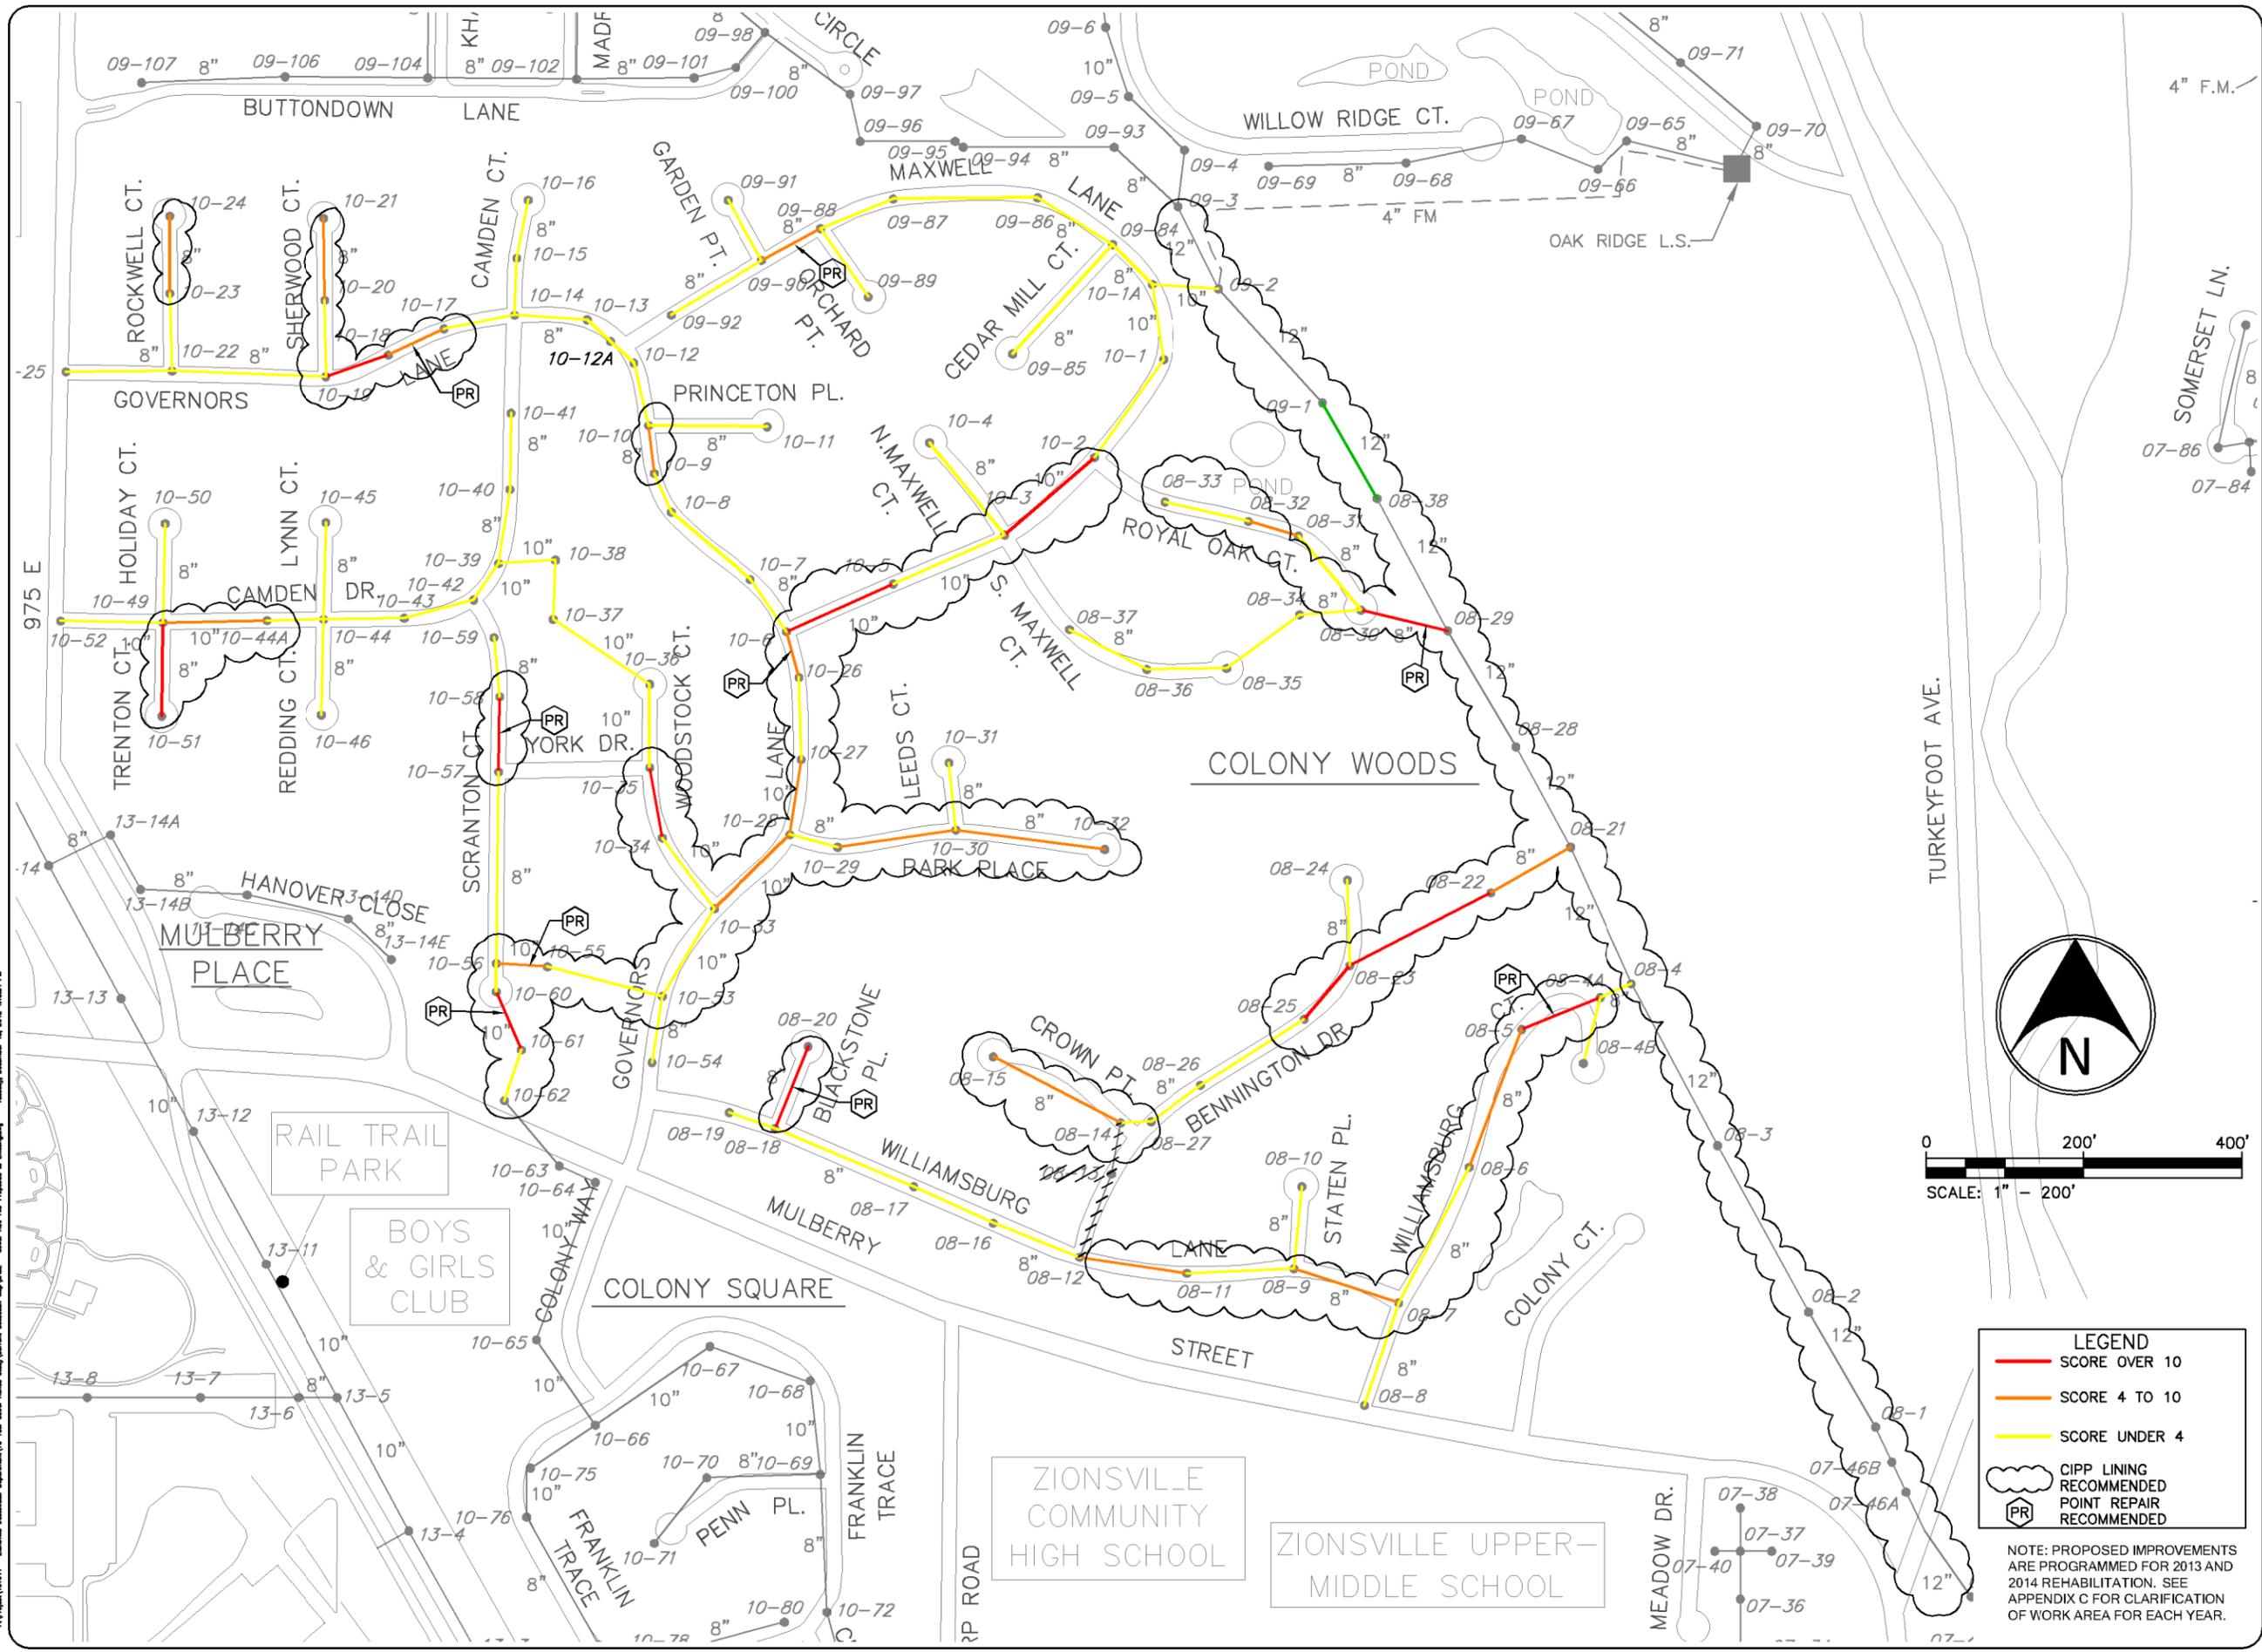
10-YEAR SEWER REHAB PROGRAM
 ZIONSVILLE COLLECTION SYSTEM
 TOWN OF ZIONSVILLE
 1100 W. OAK STREET, ZIONSVILLE, IN 46077
PROPOSED IMPROVEMENTS: COLONY WOODS

Approximately 23,300 LF of 8-inch through 12-inch sanitary sewer lines were televised in the Colony Woods neighborhood. After reviewing the inspection reports, it is recommended that 10,400 LF of pipe be rehabilitated via CIPP lining (4,200 LF high priority, 3,000 LF medium priority, and 3,200 LF low priority). Nine point repairs are also recommended.

Although not televised, Zionsville Wastewater staff requested that the remaining original portion of the Colony Woods Interceptor be rehabilitated via CIPP lining. This interceptor serves a significant portion of northern Zionsville and is difficult to access, so emergency repairs would be difficult. The rehabilitation of this interceptor would include an additional 3,900 LF of CIPP lining for 12-inch sewer line between Manhole 07-46 and Manhole 09-3. The proposed improvements for Colony Woods are shown in **Figure 1**.

Perform CIPP lining and point repair for approximately 3,900 LF of the 12-inch Colony Woods Interceptor and 4,200 LF of 8-inch gravity sewer lines within a portion of the Colony Woods neighborhood. The remaining portion of sewer rehabilitation within this neighborhood will be performed in 2014.

Perform CIPP lining and point repair for approximately 2,600 LF of 8-inch and 3,600 LF of 10-inch gravity sewer within the Colony Woods neighborhood. Additionally, replace approximately 1,100 LF of existing 6-inch gravity sewer with 8-inch pipe along Eagle View Court near the south side of Zionsville Village.

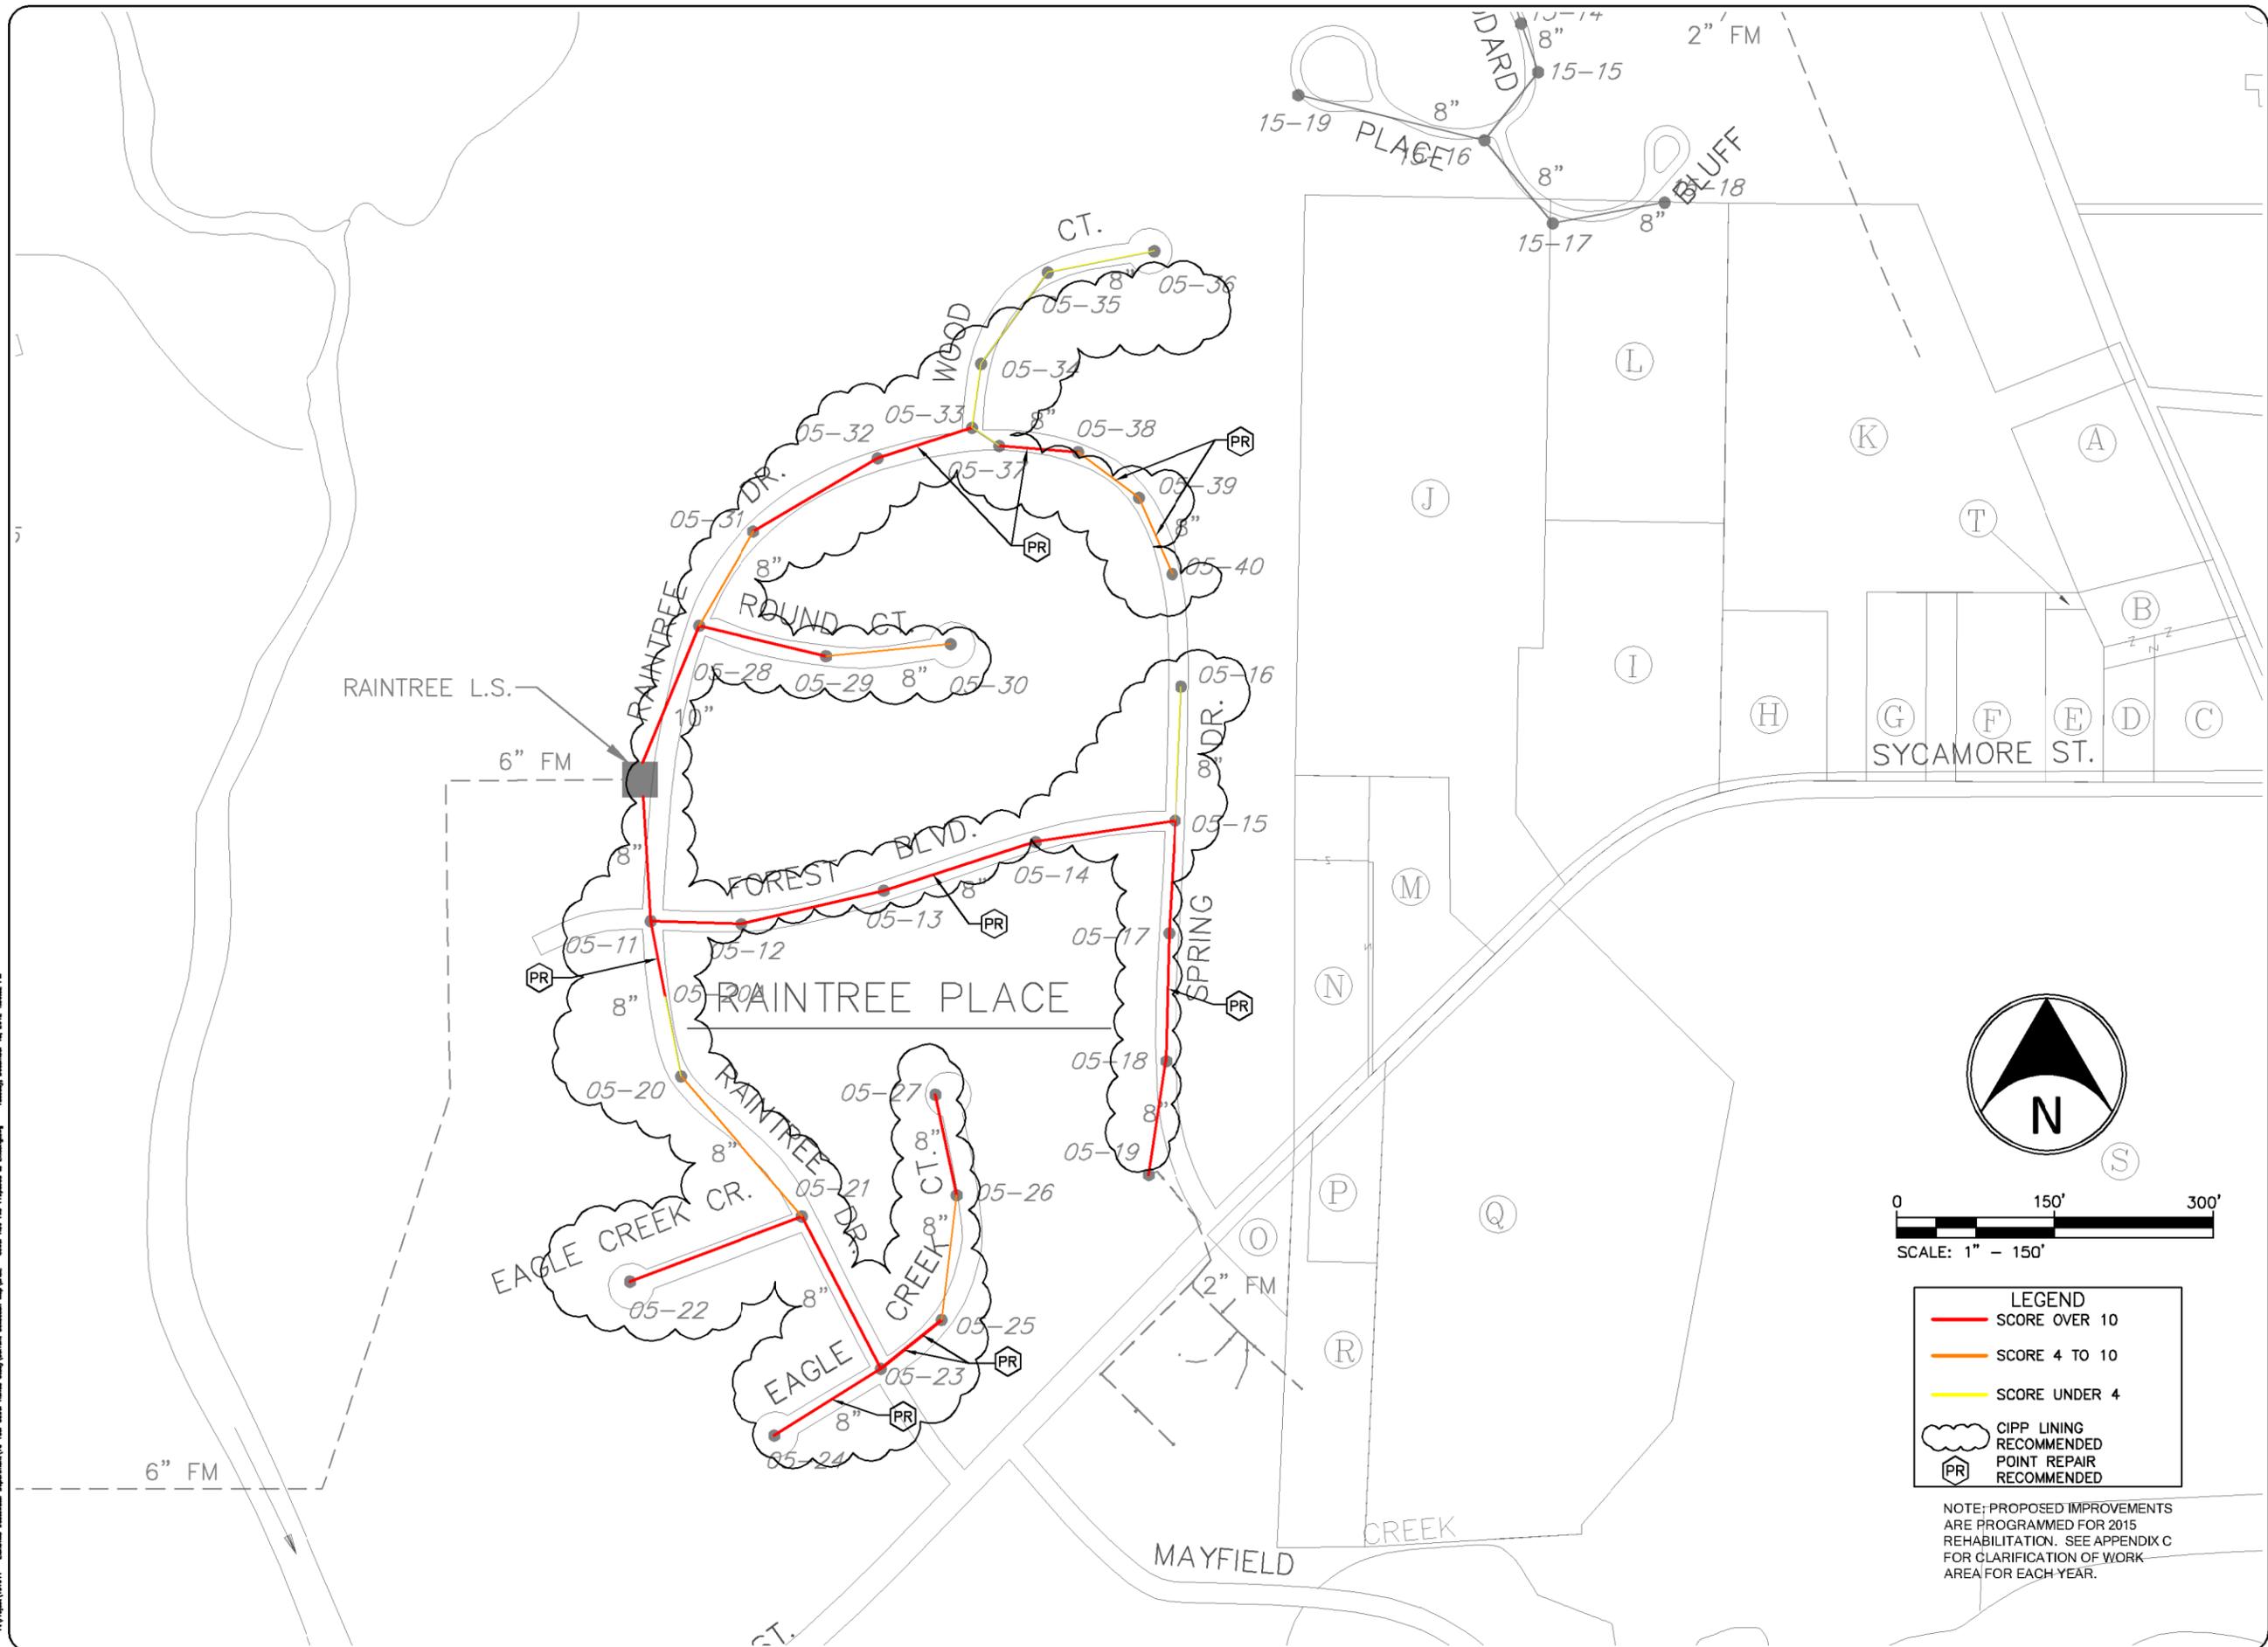
PROPOSED IMPROVEMENTS: RAIN TREE

Approximately 7,300 LF of 8-inch and 10-inch existing sewers were televised in Raintree Place. After reviewing the inspection reports, CIPP lining is recommended for all 7,300 LF (5,200 LF high priority, 1,000 LF medium priority, and 1,100 LF low priority). Ten point repairs to allow CIPP lining are also recommended. The Raintree Place proposed sewer improvements are shown in **Figure 2**.

Perform CIPP lining and point repair for approximately 6,100 LF of 8-inch and 1,200 LF of 10-inch gravity sewer within the Raintree Place development.

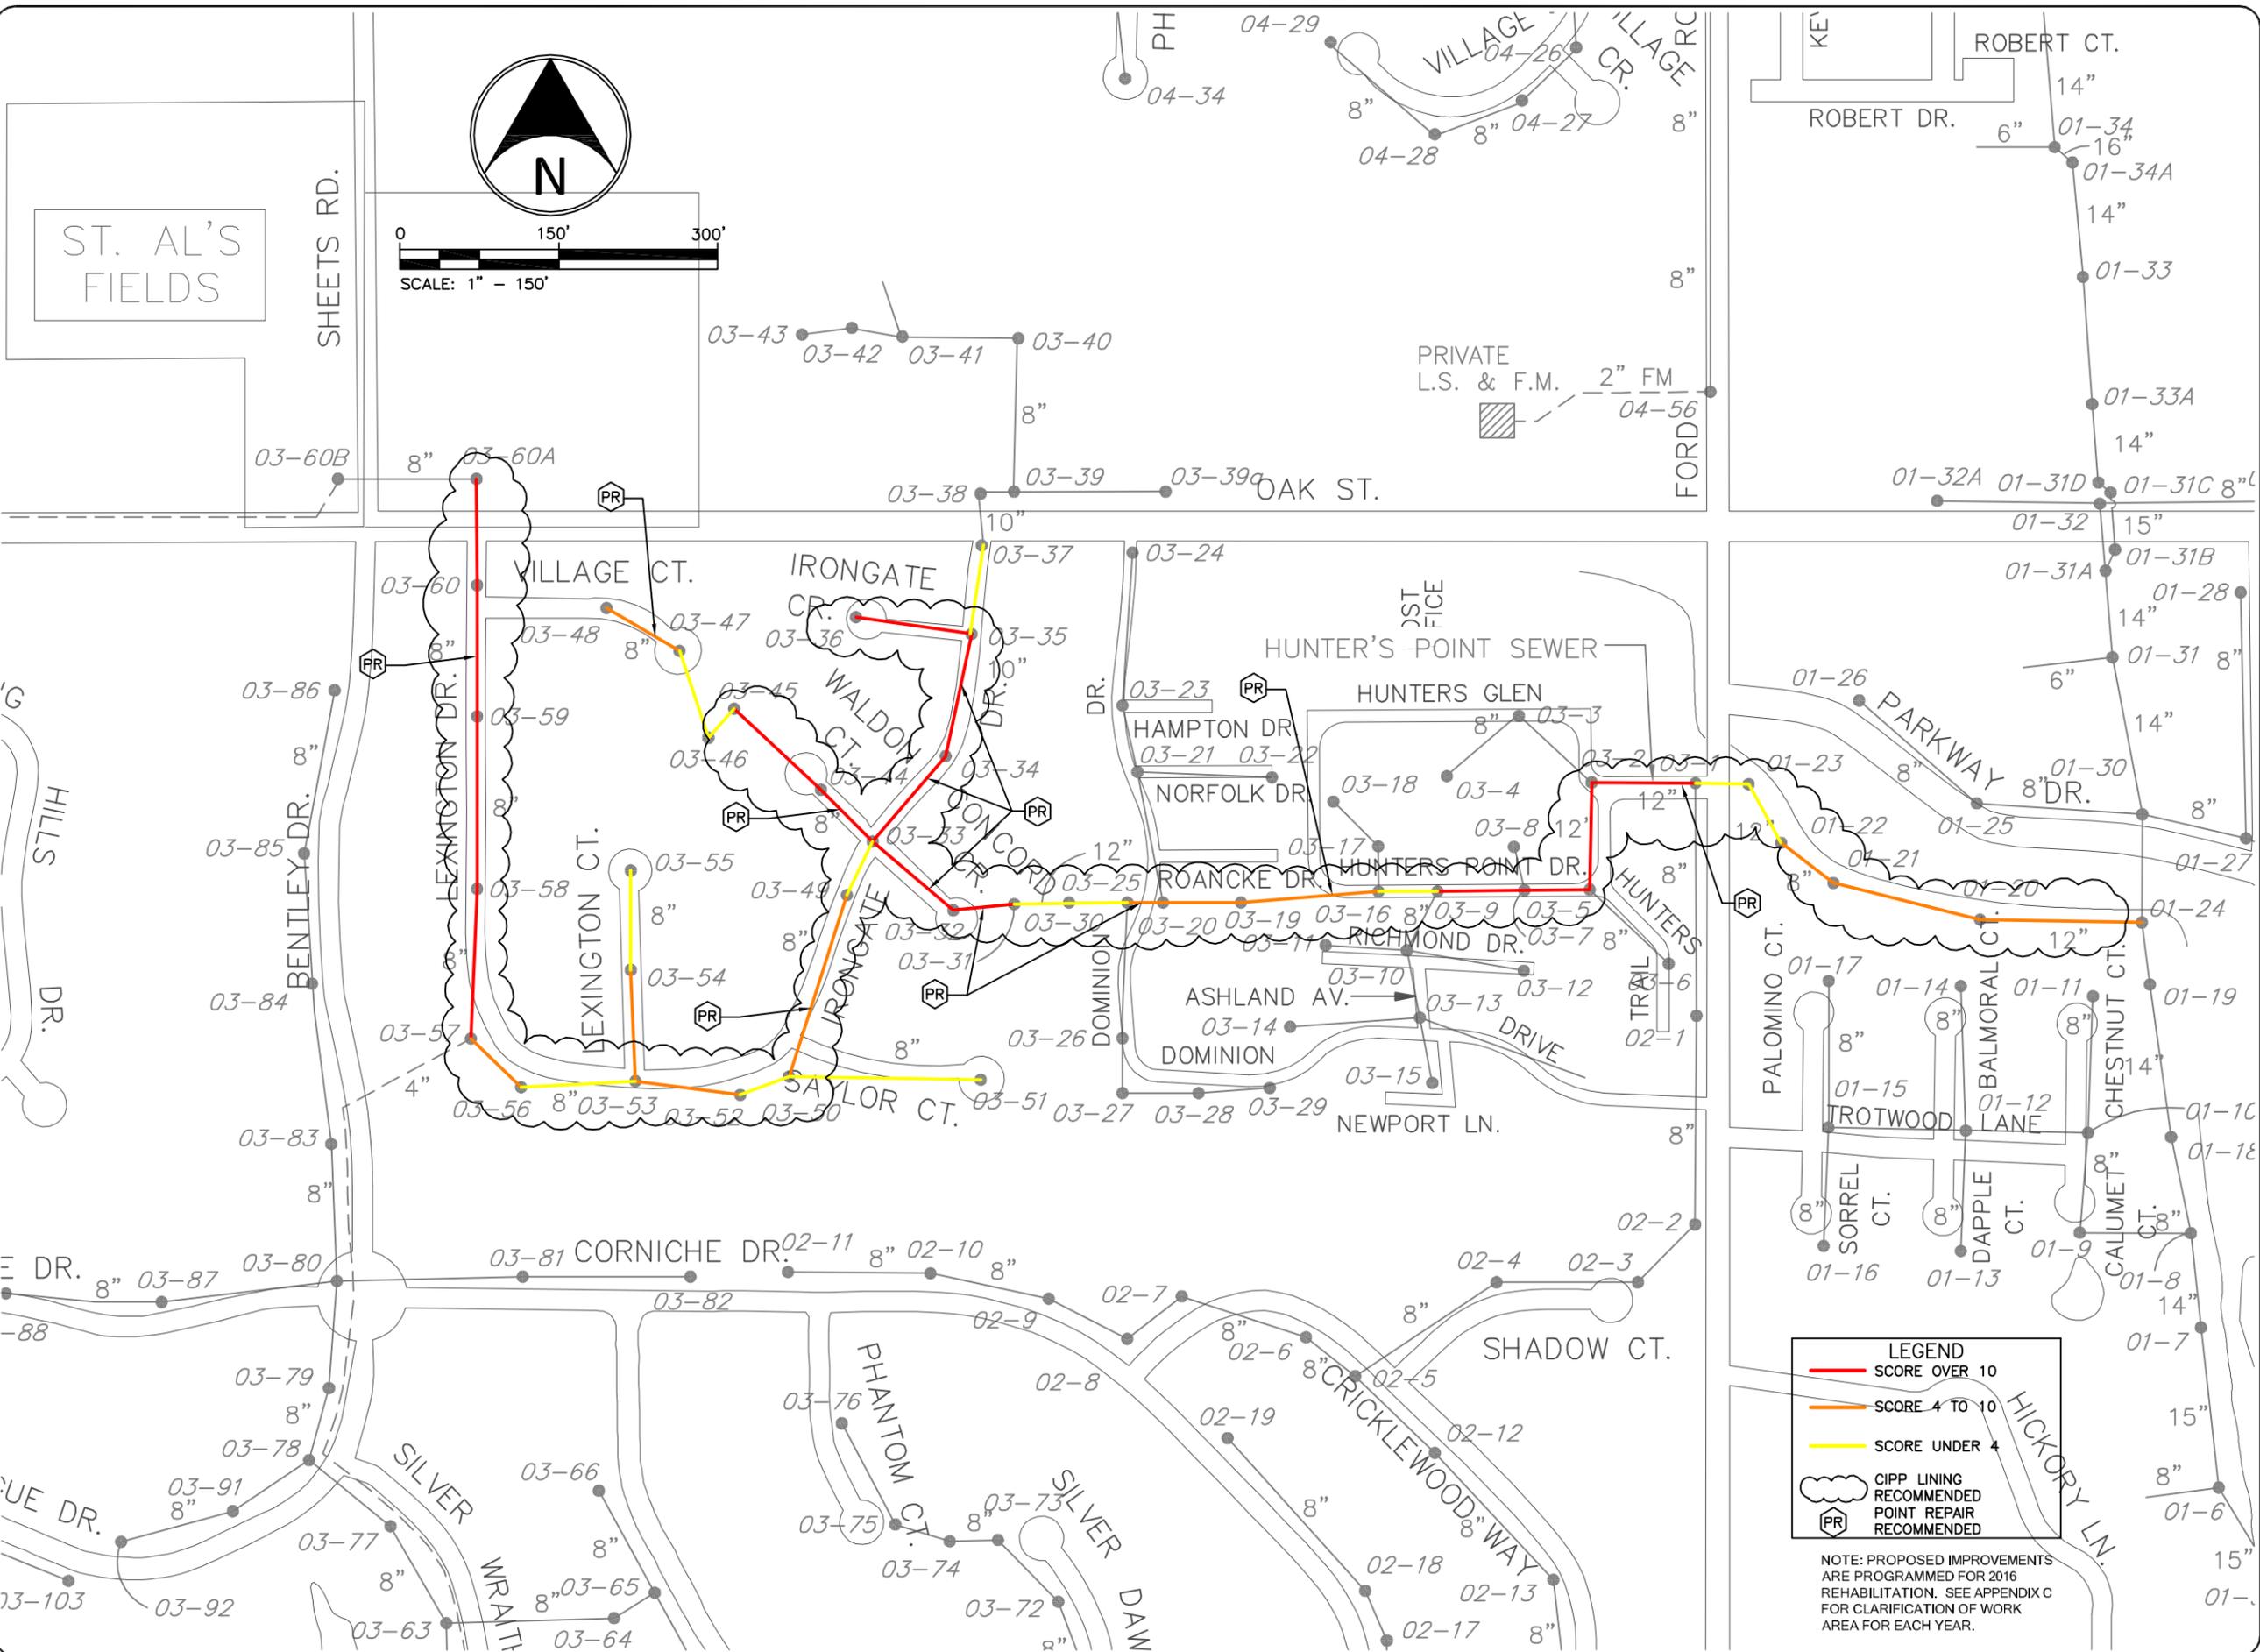
PROPOSED IMPROVEMENTS: IRONGATE

Over 7,700 LF of 8-inch through 12-inch sewers were televised in this area. Nearly 6,200 LF of CIPP lining (4,100 LF high priority, 1,300 LF medium priority, and 800 LF low priority) and eleven point repairs are recommended. Proposed improvements for this service area are shown in **Figure 3**.

CIPP lining and point repair within the Hunter's Point and Irongate neighborhoods. This work shall include rehabilitation for approximately 3,000 LF of 8-inch, 700 LF of 10-inch, and 2,600 LF of 12-inch gravity sewer lines.

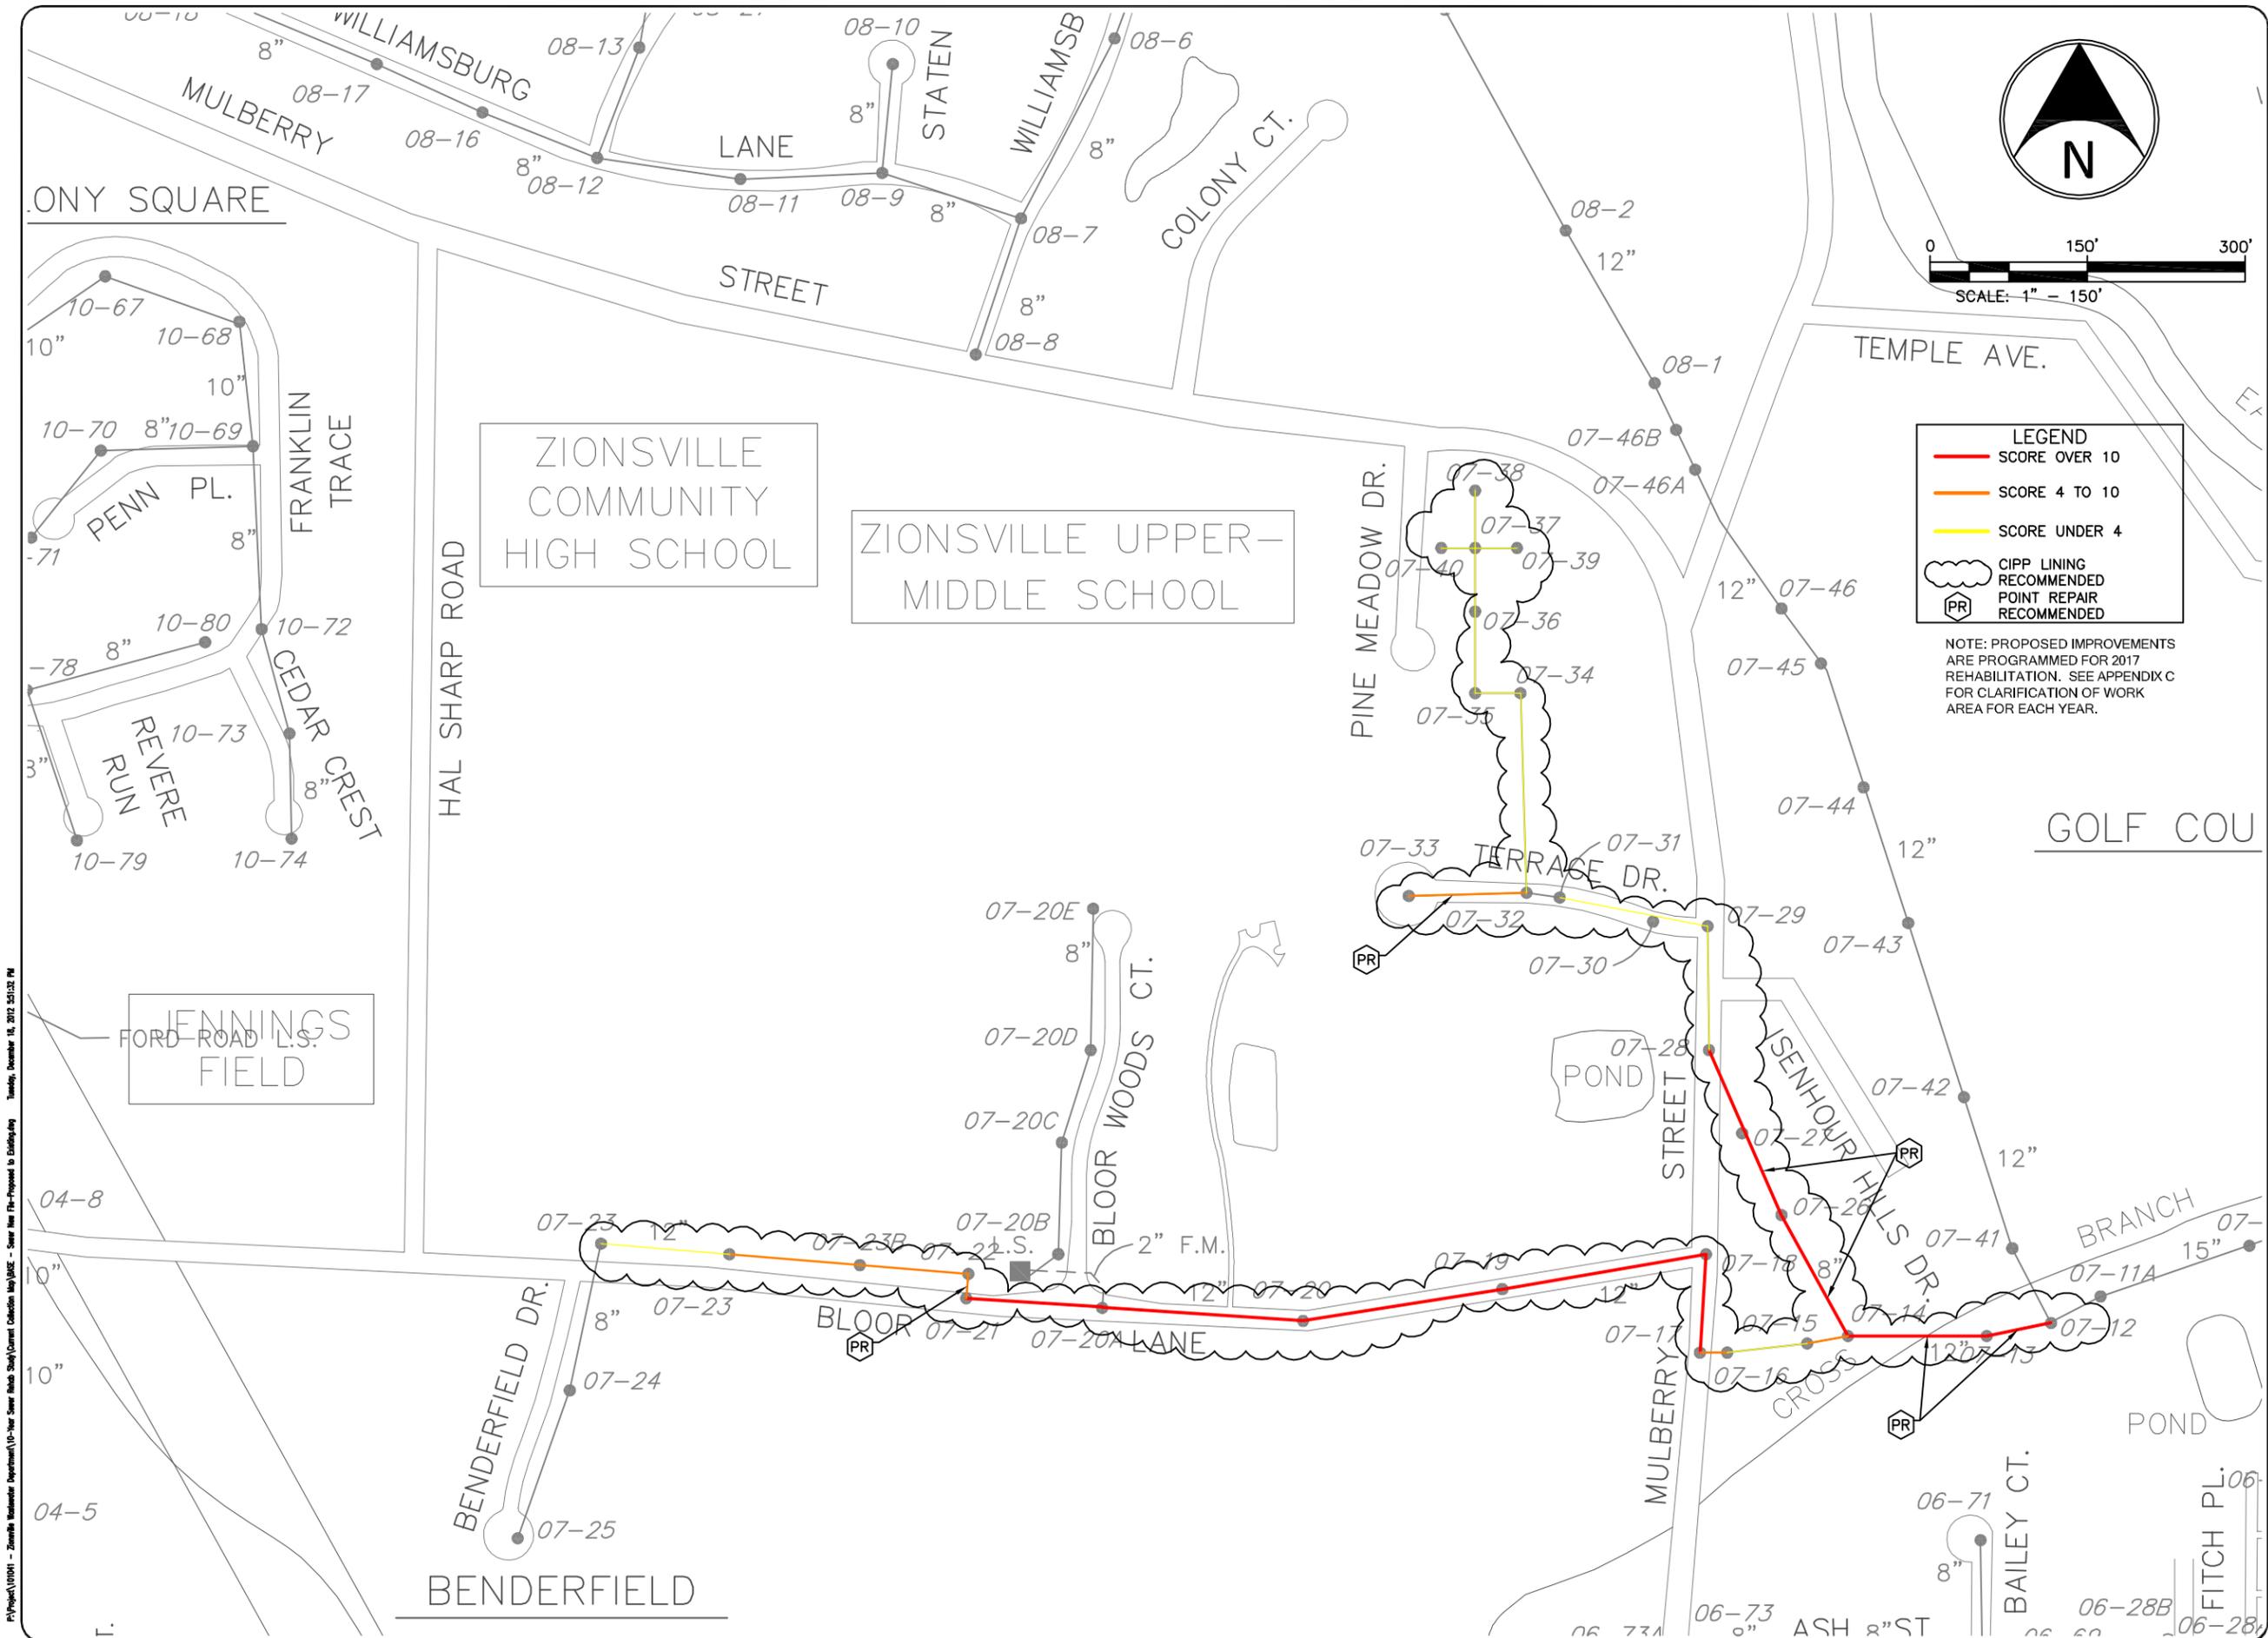
10-YEAR SEWER REHAB PROGRAM
 ZIONSVILLE COLLECTION SYSTEM
 TOWN OF ZIONSVILLE
 1100 W. OAK STREET, ZIONSVILLE, IN 46077
PROPOSED IMPROVEMENTS: BLOOR LANE

Approximately 5,800 LF of 8-inch through 12-inch sewers were televised in these neighborhoods. Over 4,500 LF of these sewers are recommended for CIPP lining (2,100 LF high priority, 1,400 LF medium priority, and 1,000 LF low priority). Six point repairs are also recommended. These proposed improvements are shown in **Figure 4**.

Perform CIPP lining and point repair for approximately 1,800 LF of 8-inch, 500 LF of 10-inch, and 2,200 LF of 12-inch gravity sewer near Bloor Lane and Isenhour Hills Drive. Additionally, perform CIPP lining and point repairs for approximately 2,300 LF of 8-inch sewer within the Sugarbush Hill neighborhood.

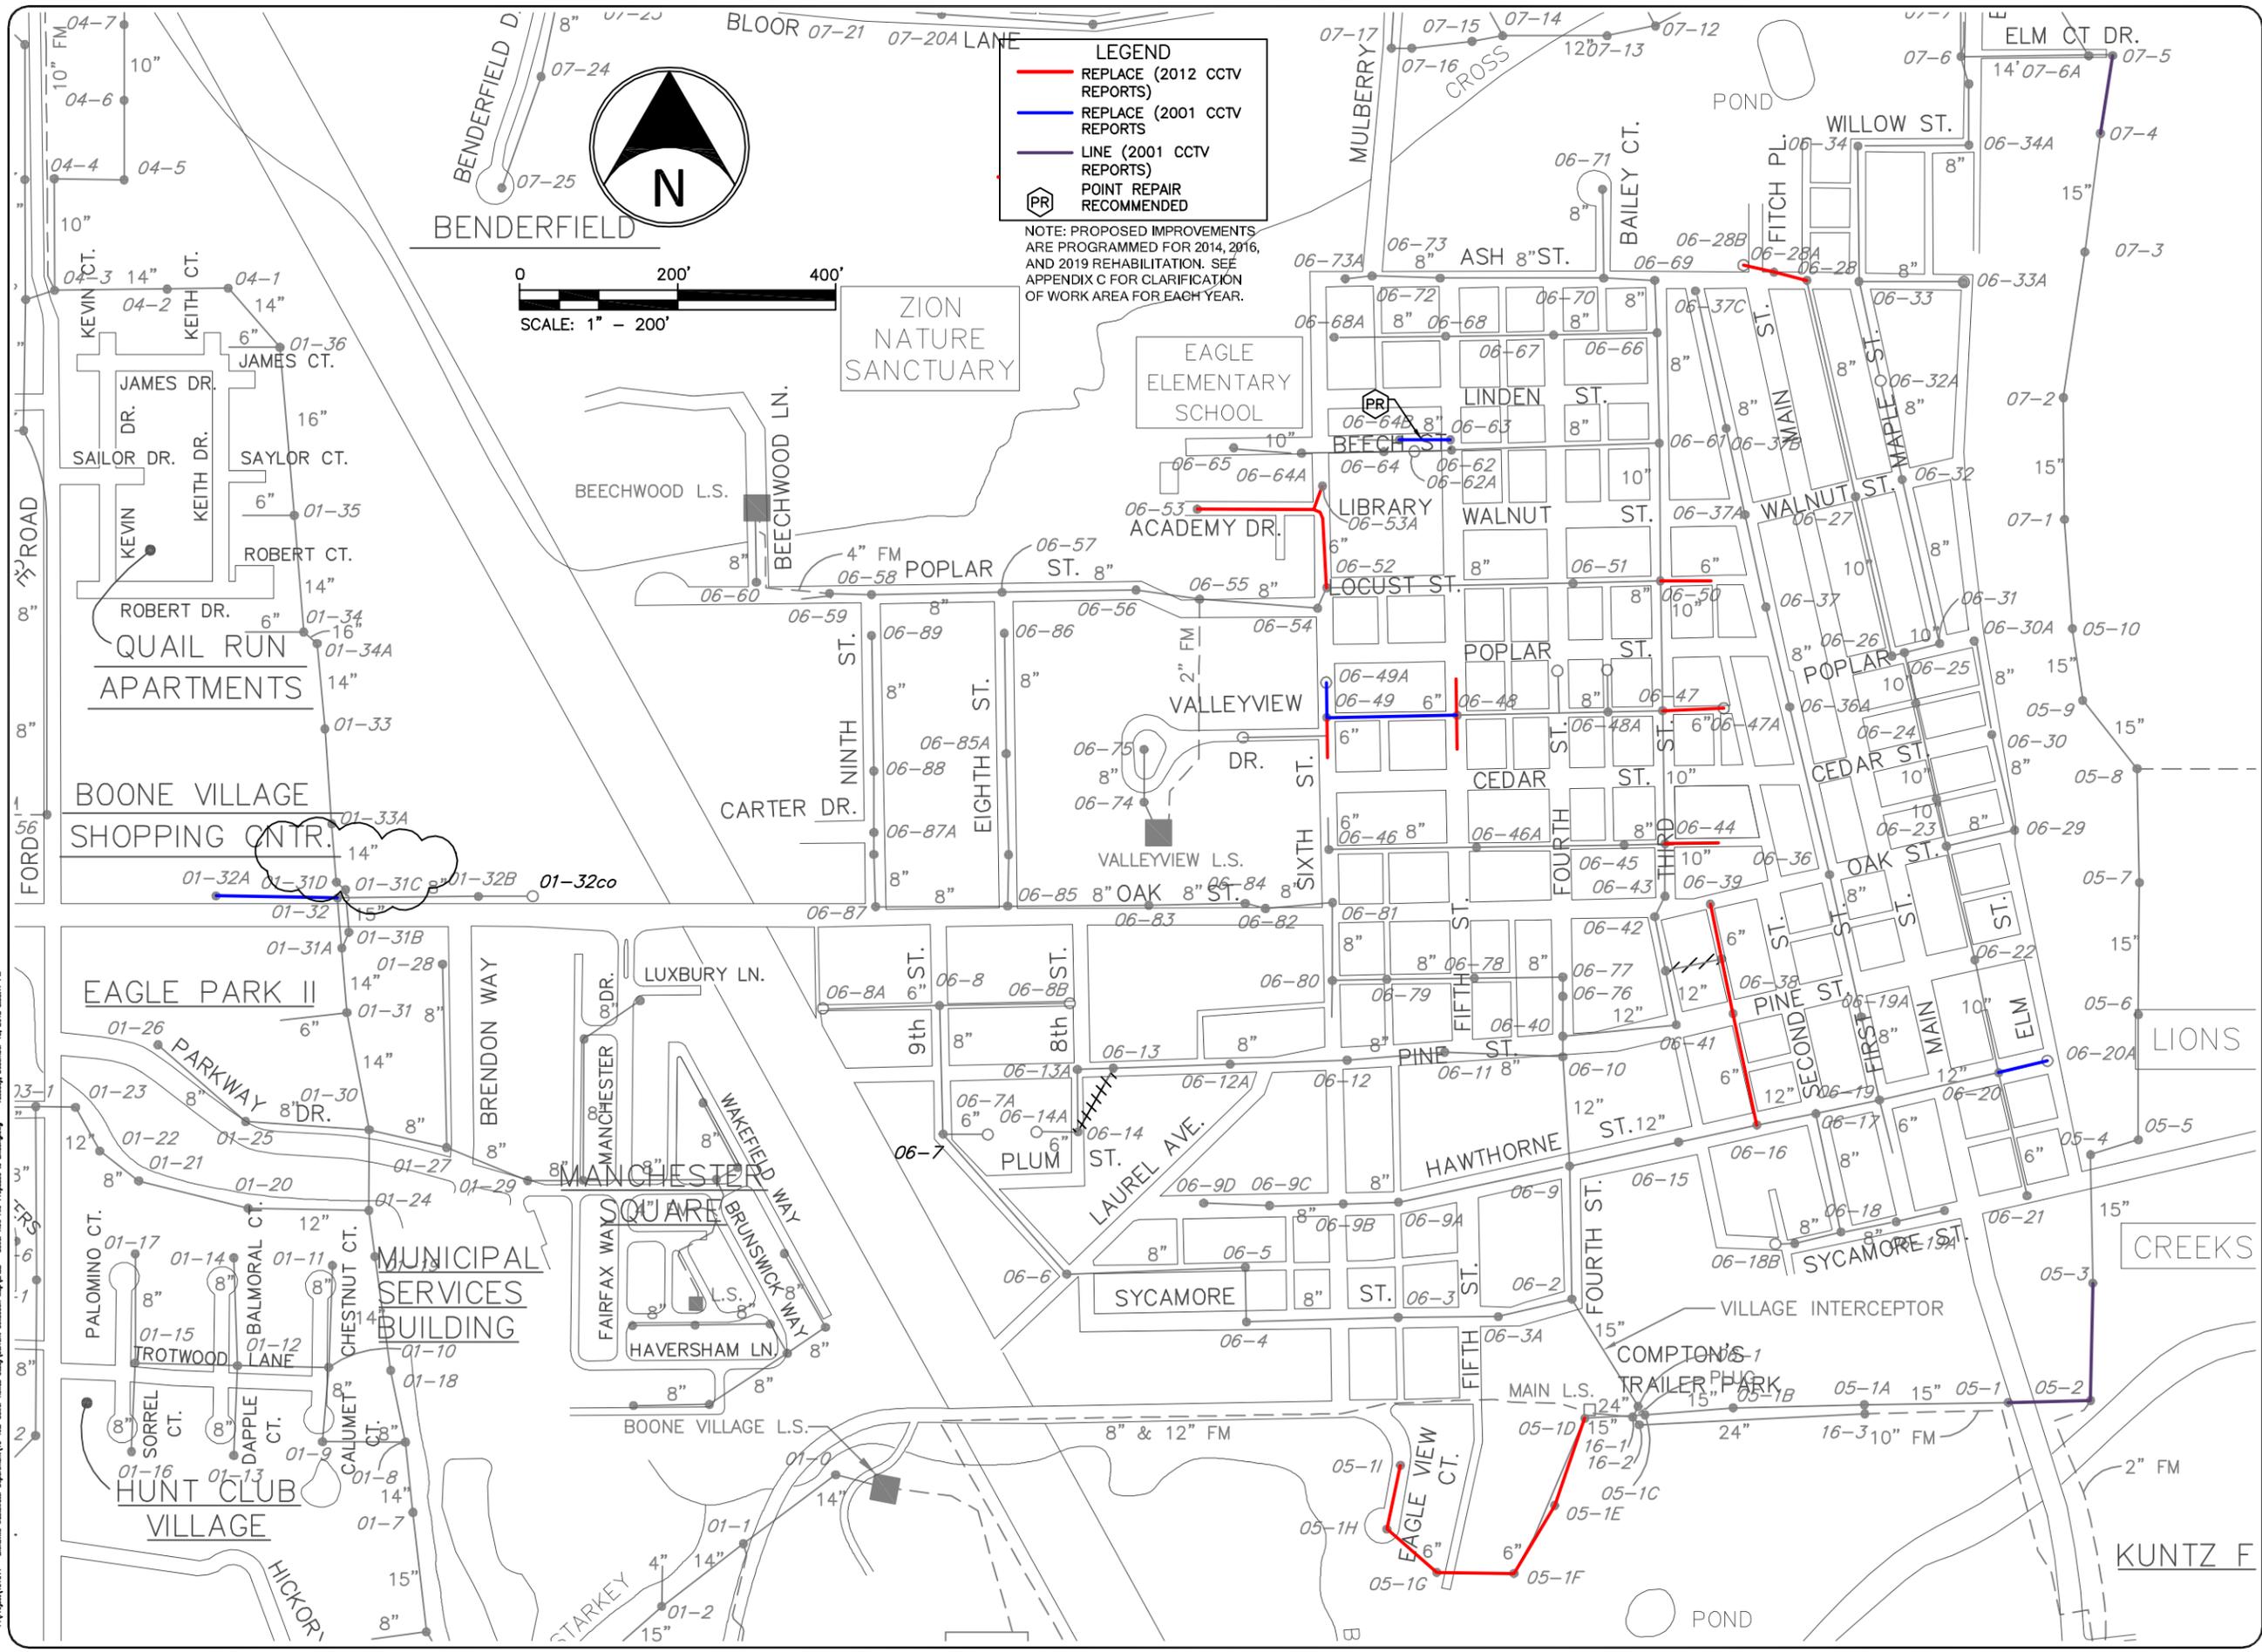
PROPOSED IMPROVEMENTS: DOWNTOWN

Approximately 5,400 LF of 6-inch through 15-inch sewers were televised throughout the Zionsville Village area. 4,300 LF of 6-inch sewers are recommended to be replaced with new 8-inch lines. Another 800 LF of the 15-inch Eastern Interceptor between Manhole 05-1 and Manhole 05-3 is recommended for CIPP rehabilitation. One point repair is also recommended on the 8-inch line between Manhole 06-64B and 06-63. The proposed improvements for this area are shown in **Figure 6**.

Replace approximately 2,600 LF of existing 6-inch gravity sewer with new 8-inch pipe in various locations throughout Zionsville Village. Additionally, perform CIPP lining and point repairs for approximately 800 LF of a portion of the 15-inch Eastern Interceptor near Creekside Park.
