**RESOLUTION NO. 2025-13**

**A RESOLUTION OF THE ZIONSVILLE TOWN COUNCIL APPROVING AN UPDATE  
TO THE TOWN OF ZIONSVILLE AMERICANS WITH DISABILITIES ACT  
TRANSITION PLAN**

Accessibility Assessment Conditions Report

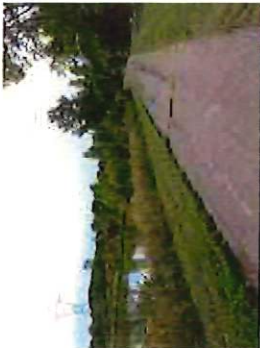
| Location | Solution / Description and Recommendation | Priority | Cost Estimate |
|---|---|---|---|
| | <b><i>Provide orientation signage for shared use path</i></b> | Priority 2 -<br>Serious | \$5,000 |
| | <p>This site includes a paved trail that also serves as a connector to the Big-4 Rail Trail. There is no orientation signage on the shared used path to give visitors an understanding of the current location, the route of the path, and proximity to other landmarks.</p> <p>Consider the installation of trailhead signage on the shared use path to provide visitors with orientation information on the current location, the route of the path, proximity to other streets and landmarks, and amenities. Similar to pedestrian recreation trails, information on the characteristics of the shared use path is helpful to visitors such as including the length of the trail or trail segment; surface type; average and minimum tread width; average and maximum running slope; and average and maximum cross slope. Information on the sign should also include accessible features like parking, restrooms, picnic areas, air stations, drinking fountains, street crossings, and locations where the accessible route may deviate from the shared use path. Consider a simple map design with high contrast between foreground and background, sans serif font, and textures for tactile orientation.</p> <p>Reference: ADA Program Access 35.149<br/>Photo: CarterStationPark-005<br/>Record #: 6<br/>Cost Note: Estimate for design services for trailhead map of shared use path.</p> | | |

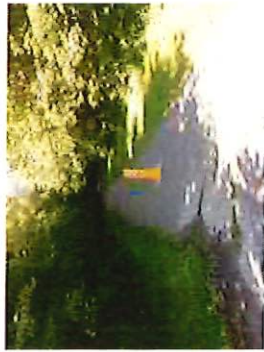
| Location | Solution / Description and Recommendation | Priority | Cost Estimate |
|---|---|---|---|
| <br><u>Trailhead</u> | <b><i>Provide trailhead signage with accessibility information</i></b><br><br>The park includes a paved pedestrian trail. There is no trailhead kiosk or posted objective information on the trail characteristics.<br><br>Provide visitor information on trailhead signage including the length of the trail or trail segment; surface type; average and minimum tread width; average and maximum running slope; and average and maximum cross slope. Utilize a design format with sans serif font, high contrast between the foreground and background colors, and font sized to the appropriate viewing distance. Consider developing a tactile map and/or model to effectively communicate locations of attractions, topography, features, and points of interest to orientate visitors with visual or cognitive impairments.<br><br>Reference: ADA Program Access 35.149; ABAS 1017.10<br>Photo: CreeksideNaturePark-010<br>Record #: 9<br>Cost Note: Estimate to install trailhead sign with map and trail characteristics. | Priority 2 -<br>Serious | \$5,000 |

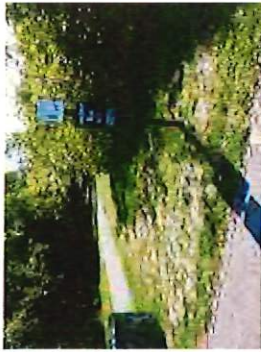
| Location | Solution / Description and Recommendation | Priority | Cost Estimate |
|---|---|---|---|
| <br><u>Parking</u> | <b><i>Lower/relocate dog waste bag dispenser</i></b><br><br>The dog waste bag dispenser is mounted on the sign post. The outlet for the dog waste bag dispenser is greater than 48 inches above the ground surface and located in grass, outside of the reach range on the accessible route.<br><br>Relocate the dog waste bag dispenser to within the reach range of the accessible route. Lower the dog waste bag dispenser on the post. The outlet for the dispenser should not exceed an unobstructed reach of 48 inches above the ground surface. If an obstructed reach over the trash receptacle is necessary, the outlet should not exceed 44 inches above the ground surface with a maximum depth of 25 inches.<br><br>Reference: ADA 308<br>Photo: CreeksideNaturePark-008<br>Record #: 12<br>Cost Note: Estimate to move post. | Priority 2 -<br>Serious | \$200 |

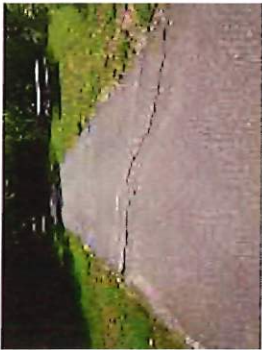
| Location | Solution / Description and Recommendation | Priority | Cost Estimate |
|---|---|---|---|
| | <p><u>Paved Park Trail</u></p> <p><b><i>Correct changes in level/openings for accessible route</i></b></p> <p>There are sections of the paved asphalt park trail that have heaves, openings in the surface and changes in level.</p> <p>Adopt a cyclical maintenance schedule to repair and resurface sections of the paved asphalt park trail.</p> <p>Reference: ADA 302.3, 303, 403.4</p> <p>Photo: CreeksideNaturePark-006</p> <p>Record #: 10</p> <p>Cost Note: Operations.</p> | Priority 3 - Moderate | |

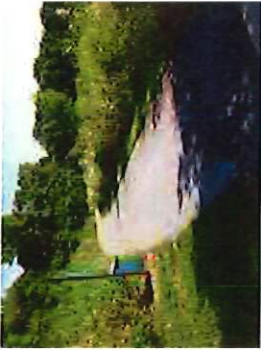
| Location | Solution / Description and Recommendation | Priority | Cost Estimate |
|---|---|---|---|
| | <b>Provide trailhead signage with accessibility information</b><br><br>A concrete and asphalt recreational trail/shared use path cuts through the park. There is no visitor information on the trail characteristics.<br><br>Consider installing trailhead signs at the main parking lot and the approach to the park from the Elm Street parking lot. Provide visitor information on trailhead signage including the length of the trail or trail segment; surface type; average and minimum tread width; average and maximum running slope; and average and maximum cross slope.<br><br>Reference: ADA Program Access 35.149; ABAS 1017.10<br>Photo: ElmStGreen-052<br>Record #: 20<br>Cost Note: Estimate to install trailhead sign with map and trail characteristics x 2. | Priority 1 - Critical | \$10,000 |

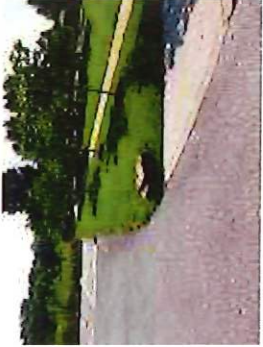
| Location | Solution / Description and Recommendation | Priority | Cost Estimate |
|---|---|---|---|
| | <b>Install/extend accessible route</b><br>There is no accessible route forward of the accessible parking space connecting the site arrival point to the main park path. Visitors with disabilities must enter the vehicular roadway to access the sidewalk where the approach from the curb has a running slope up to 12.5%<br>Provide an accessible route connecting the site arrival point to the park amenities. Install a concrete path forward of the accessible parking space and access aisle and connecting to the main park path not to exceed a running slope of 5% and a cross slope of 2.08%. | Priority 1 - Critical | \$4,000 |
| | Reference: ADA 402<br>Photo: ElmStGreen-047<br>Record #: 25<br>Cost Note: Estimate to install concrete path 30 ft x 5 ft. | | |

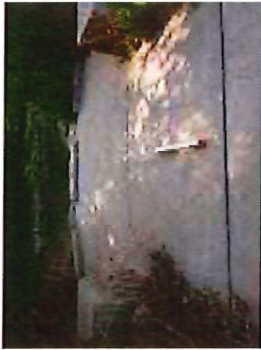
| Location | Solution / Description and Recommendation | Priority | Cost Estimate |
|---|---|---|---|
| | <p><b><i>Modify existing pathway</i></b></p> <p>The concrete path to the fishing area and kayak launch has a running slope over 5% and up to 9.9% for a distance of 40 ft.</p> <p>Remove the section of concrete, grade, and install new concrete path not to exceed a running slope of 5% and a cross slope of 2.08%.</p> <p>Reference: ADA 402<br/> Photo: ElmStGreen-043<br/> Record #: 22<br/> Cost Note: Estimate to remove section of concrete, grade, and install concrete path 40 ft x 5 ft.</p> | Priority 2 - Serious | \$6,000 |

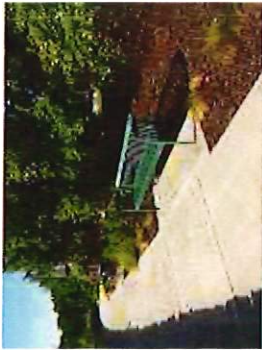
| Location | Solution / Description and Recommendation | Priority | Cost Estimate |
|---|---|---|---|
| | <p>Upper Park Path at West Picnic Shelter</p> <p><b><i>Provide clear ground space adjacent to bench</i></b></p> <p>There are 6 benches installed along the upper park path. The units are mounted on concrete pads adjacent to the park path but lack space for wheelchair seating.</p> <p>Widen the concrete pads at 2 of the benches to provide space for wheelchair seating. As benches are installed, repaired or replaced, ensure a minimum of 20 percent are accessible, adjacent to the accessible route with clear ground space for wheelchair seating. For benches, provide styles with back supports and at least one armrest along with a minimum clear ground space 36 x 48 inches positioned near the bench with one side of the space adjoining an accessible route, outdoor recreation access route or trail. The clear ground space shall not overlap the accessible route or trail, or another clear ground space.</p> <p>Reference: <i>ABAS-Outdoor 1011</i><br/> Photo: <i>ElmStGreen-054</i><br/> Record #: <i>27</i><br/> Cost Note: <i>Estimate to widen concrete pads by 24 sq ft x 2.</i></p> | Priority 2 - Serious | \$1,100 |

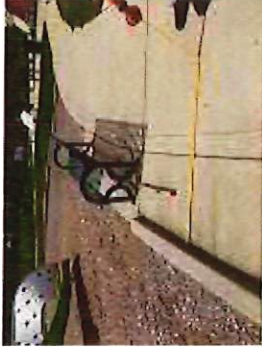
| Location | Solution / Description and Recommendation | Priority | Cost Estimate |
|---|---|---|---|
| | <p><b><u>Park</u></b></p> <p><b><i>Provide clear ground space adjacent to bench</i></b></p> <p>Benches are installed throughout the park and located adjacent to the accessible route. However at some locations, like the playground, concrete curbs have been installed as wheel stops and the 48 inch depth of the clear floor space overlaps the circulation path.</p> <p>As benches are installed, repaired or replaced, ensure a minimum of 20 percent are accessible, adjacent to the accessible route with clear ground space for wheelchair seating. For benches, provide styles with back supports and at least one armrest along with a minimum clear ground space 36 x 48 inches positioned near the bench with one side of the space adjoining an accessible route, outdoor recreation access route or trail. The clear ground space shall not overlap the accessible route or trail, or another clear ground space.</p> <p>Reference: ABAS-Outdoor 1011<br/> Photo: HeritageTrailPark-059<br/> Record #: 42<br/> Cost Note: Estimate to install benches x 2 on concrete pad.</p> | <p>Priority 2 - Serious</p> | <p>\$4,800</p> |

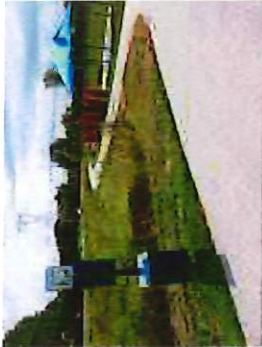
| Zionsville Parks and Recreation | | Accessibility Assessment Conditions Report | | |
|---|---|---|---|--|
| <div> </div> | <p><b>Park</b></p> <p><b><i>Lower/relocate dog waste bag dispenser</i></b></p> <p>The dog waste bag dispensers are mounted on posts throughout the park. The outlet for the dog waste bag dispenser is greater than 48 inches above the ground surface with an obstructed reach over the trash receptacle. The units are set back from the main park path in grass, outside of the reach range on the accessible route.</p> <p>Lower the dog waste bag dispensers within the reach range of the accessible route and such that the outlet does not exceed an unobstructed reach 48 inches above the ground surface. If an obstructed reach over the trash receptacle is necessary, the outlet should not exceed 44 inches above the ground surface with a maximum depth of 25 inches.</p> <p>Reference: ADA 308</p> <p>Photo: HeritageTrailPark-056</p> <p>Record #: 41</p> <p>Cost Note: Estimate to lower dog waste bag dispenser on post x 3.</p> | <p>Priority 3 - Moderate</p> | \$180 | |

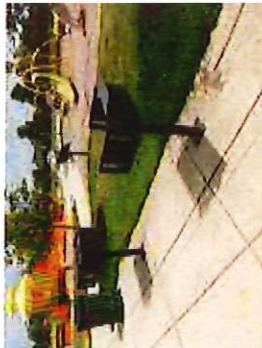
| Location | Solution / Description and Recommendation | Priority | Cost Estimate |
|---|---|---|---|
| | <p><u>Picnic Shelter</u></p> <p><b><i>Provide accessible fire ring/grill</i></b></p> <p>There are 2 pedestal grills serving the picnic shelter. The units are mounted in concrete. The concrete surface does not extend to the back side of at least 1 unit to provide the minimum clear width on all usable sides.</p> <p>Extend the concrete surface area to a minimum of 1 pedestal grill to provide a minimum 48 x 48 inch clear ground space on all usable sides of the unit. The accessible fire ring/grill shall be installed with fire building surface 9 inches minimum from the ground, a cooking surface 15 to 34 inches maximum from the ground.</p> <p>Reference: <i>ABAS-Outdoor F245, 1011.5</i></p> <p>Photo: HeritageTrailPark-024</p> <p>Record #: 34</p> <p>Cost Note: Estimate to extend concrete pad 4 ft x 6 ft.</p> | Priority 2 - Serious | \$800 |

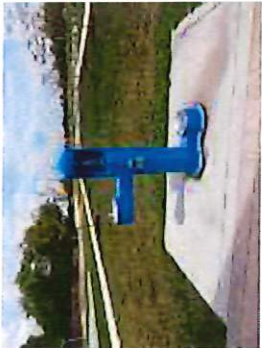
| Location | Solution / Description and Recommendation | Priority | Cost Estimate |
|---|---|---|---|
| | <p><u>Picnic Shelter</u></p> <p><b><i>Add/replace existing drinking fountain with high-low unit</i></b></p> <p>There is a wheelchair accessible drinking fountain with bottle filler and dog bowl set back from the main circulation route. The leading bottom edge is 27 1/2 inches above the ground surface and lacks cane detection for people with visual impairments. There is no high standing drinking fountain in the proximity for people who have difficulty bending or stooping.</p> <p>Install a high drinking fountain in the proximity for people who have difficulty bending or stooping. The standing unit shall have spout height 38 to 43 inches above the finish floor.</p> <p>When the existing wheelchair accessible drinking fountain is replaced, install with a high-low combination unit in order to provide both a wheelchair accessible height fountain and a standing height fountain. The wheelchair accessible unit shall be positioned for a forward approach with knee clearance a minimum 27 inches above the finish floor (and be cane detectable at 27 inches) and a spout height of 36 inches maximum. The standing unit shall have spout height 38 to 43 inches above the finish floor.</p> <p>Reference: <i>ADA 211, 602</i></p> <p>Photo: HeritageTrailPark-025</p> <p>Record #: 35</p> <p>Cost Note: Estimate to install high standing drinking fountain.</p> | Priority 3 - Moderate | \$3,000 |

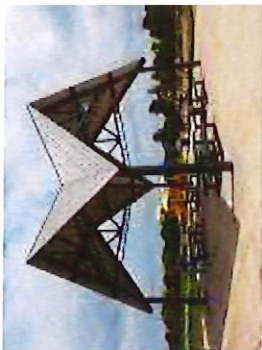
| Location | Solution / Description and Recommendation | Priority | Cost Estimate |
|---|---|---|---|
| | <p><u>Picnic Shelter</u></p> <p><b><i>Configure picnic area for clear floor space around picnic tables</i></b></p> <p>There are 4 accessible fixed picnic tables serving the shelter.</p> <p>Design a floor plan for the picnic shelter with placement of picnic tables. Configure the picnic area so that at least 20 percent, but not less than two accessible picnic tables have space for wheelchair seating at least 30 inches wide with knee clearance and a minimum 36 inch clear width around all usable sides of the table measured from the back edge of the bench.</p> <p>Reference: <i>ABAS-Outdoor F245.2, 1011.2, 1011.4</i></p> <p>Photo: HeritageTrailPark-021</p> <p>Record #: 36</p> <p>Cost Note: Estimate to design floor plan for picnic shelter.</p> | Priority 3 - Moderate | \$50 |

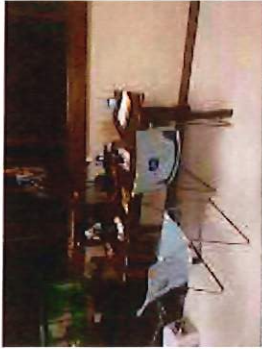
| Location | Solution / Description and Recommendation | Priority | Cost Estimate |
|---|---|---|---|
| | <b><i>Provide accessible desk/work surface</i></b><br><br>The desk for the microscope viewing station lacks knee clearance. The knee clearance is obstructed by the desk frame at 25 inches above the finish floor.<br><br>Provide an accessible work surface for the microscope viewing station with the top of the surface 28-34 inches above the finish floor, a minimum width of 30 inches, and knee clearance a minimum of 27 inches above the finish floor.<br><br>Reference: ADA 902<br>Photo: ZNatureCtr-023<br>Record #: 123<br>Cost Note: Estimate to install accessible desk/table. | Priority 2 - Serious | \$500 |

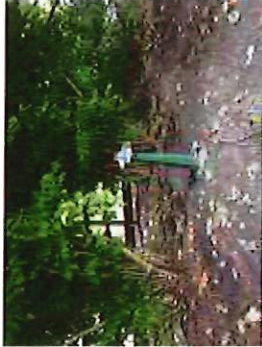
| Location | Solution / Description and Recommendation | Priority | Cost Estimate |
|---|---|---|---|
| | <p><u>Open Picnic Area</u></p> <p><b>Add/replace existing drinking fountain with high-low unit</b></p> <p>There is a standard drinking fountain in grass. The unit does not meet the accessibility standards for a low wheelchair accessible unit or the high standing unit.</p> <p>Install a new accessible high-low drinking fountain in order to provide both a wheelchair accessible height fountain and a standing height fountain. Install the unit along the accessible route with clear floor space centered at each unit and not to exceed a slope of 2.08% in all directions. The wheelchair accessible unit shall be positioned for a forward approach with knee clearance a minimum 27 inches above the finish floor (and be cane detectable at 27 inches) and a spout height of 36 inches maximum. The standing unit shall have spout height 38 to 43 inches above the finish floor.</p> <p>Reference: ADA 211, 602</p> <p>Photo: LincolnPark-021</p> <p>Record #: 51</p> <p>Cost Note: Estimate to install outdoor high-low drinking fountain.</p> | Priority 1 - Critical | \$4,500 |

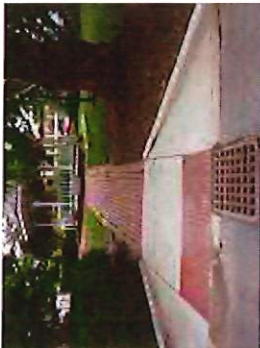
| Location | Solution / Description and Recommendation | Priority | Cost Estimate | | |
|---|---|---|---|--|--|
| | While a compliant concrete curb cut has been installed on the west side of the park for direct access to the gazebo, the curb cut is bordered by a storm drain grate with openings greater than 1/2 inch diameter. The curb cut can be blocked by parked vehicles. | Priority 2 -<br>Serious | \$3,000 | | |

| Location | Solution / Description and Recommendation | Priority | Cost Estimate | | |
|---|---|---|---|--|--|
| | Consider shifting the placement of the storm drain grate to the north or south outside of the direct path of the curb cut and park path. Also consider the placement of the accessible on-street parking space and pavement striping to prohibit vehicles from obstructing the curb cut. Replace the storm drain grate with a design with openings that do not exceed 1/2 inch diameter. | | | | |

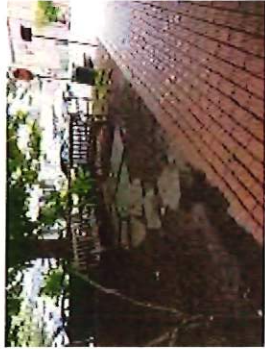
| Location | Solution / Description and Recommendation | Priority | Cost Estimate |
|---|---|---|---|
| | <b><u>Park</u></b><br><b><i>Provide clear ground space adjacent to bench</i></b><br>Benches are installed throughout the park. The units are mounted in grass or the landscape bed outside of the connection to an accessible route.<br>Install 2 benches along the accessible route. As benches are installed, repaired or replaced, ensure a minimum of 20 percent are accessible, adjacent to the accessible route with clear ground space for wheelchair seating. For benches, provide styles with back supports and at least one armrest along with a minimum clear ground space 36 x 48 inches positioned near the bench with one side of the space adjoining an accessible route, outdoor recreation access route or trail. The clear ground space shall not overlap the accessible route or trail, or another clear ground space. | Priority 2 - Serious | \$4,800 |
| | Reference: ABAS-Outdoor 1011<br>Photo: LincolnPark-018<br>Record #: 54<br>Cost Note: Estimate to install benches x 2 on concrete pad. | | |

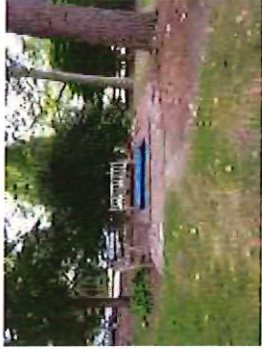
| Location | Solution / Description and Recommendation | Priority | Cost Estimate |
|---|---|---|---|
| | <b><u>Water Feature</u></b><br><b><i>Install/extend accessible route</i></b><br>There is a water feature (reflective pool) and sitting area set in grass and lined with brick pavers. There is no accessible route to the sitting area or adjacent space for wheelchair seating.<br>Evaluate the remaining life cycle for the water feature (reflective pool). Provide an accessible route to the water feature and space for wheelchair seating shoulder to shoulder adjacent to the benches. | Priority 2 - Serious | \$3,000 |
| | Reference: ADA 402<br>Photo: LincolnPark-012<br>Record #: 55<br>Cost Note: Estimate for design services. | | |

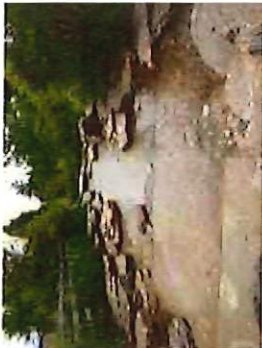
| Location | Solution / Description and Recommendation | Priority | Cost Estimate |
|---|---|---|---|
| | <p>Creek Feature Southeast of Splash Pad</p> <p><b><u>Install/extend accessible route</u></b></p> <p>There is no accessible route to enter and participate in the creek stomping activity of intended for water feature.</p> <p>Provide an accessible route to enter and participate in the creek stomping activity. Consider the design of water play areas where the user does not have to leave their assistive device and other areas where the boulders are designed as transfer platforms/steps. A new path running parallel with the creek could also provide multiple accessible points of entry for children and adults with mobility impairments.</p> <p>Reference: ADA 402</p> <p>Photo: MulberryFields-062</p> <p>Record #: 69</p> <p>Cost Note: Estimate for design services.</p> | Priority 1 - Critical | \$3,000 |

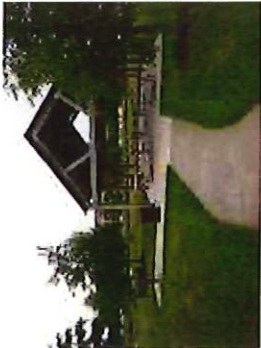
| Location | Solution / Description and Recommendation | Priority | Cost Estimate |
|---|---|---|---|
| | <p><b><u>Picnic Shelters</u></b></p> <p><b><u>Designate accessible picnic facilities</u></b></p> <p>There are 4 picnic shelters serving the park.</p> <p>Provide at least 20 percent, but not less than two, picnic units with mobility features including accessible outdoor constructed features, location on an accessible route, and wheelchair seating.</p> <p>Designate the main picnic shelter at the playground and the picnic shelter west of the splash pad as the accessible units. Picnic units with mobility features don't have to be identified by signs. However, information on the location of picnic units with mobility features should be provided for reservation and permit systems, web sites, brochures, and on the information kiosks at the site or park. Note, that while this number meets the minimum requirement to achieve "program access" at the site, the visitor experience should be considered to include additional accessible picnic shelters at the south and west side of the park.</p> <p>Reference: ADA Program Access 35.149; ABAS-Outdoor F245.2, 1011</p> <p>Photo: MulberryFields-066</p> <p>Record #: 78</p> <p>Cost Note: Operations.</p> | Priority 1 - Critical | |

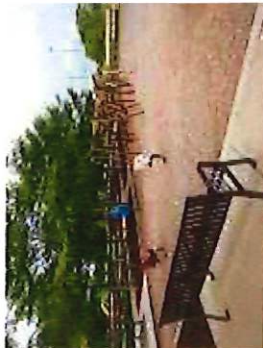
| Location | Solution / Description and Recommendation | Priority | Cost Estimate |
|---|---|---|---|
| <br><u>Playground</u> | <p><b><i>Provide accessible play surface</i></b></p> <p>The playground is surfaced with engineered wood fiber. The undulation of the surface material exceeds the maximum allowable 6.25% slope for the accessible route to play components and the maximum allowable 2.08% clear floor space at play components.</p> <p>Rake the engineered wood fiber level, replenish the surface material as necessary and compact the surface system to eliminate the undulation. Refer to the manufacturer's recommendations for installation and maintenance to ensure a level, accessible play surface not to exceed 6.25% for the accessible route and 2.08% in the clear floor spaces for accessible play components.</p> <p>Reference: ADA 240, 1008<br/>Photo: MulberryFields-049<br/>Record #: 68<br/>Cost Note: Estimate top dress EWF for 3,000 sq ft with compaction.</p> | Priority 2 - Serious | \$3,500 |

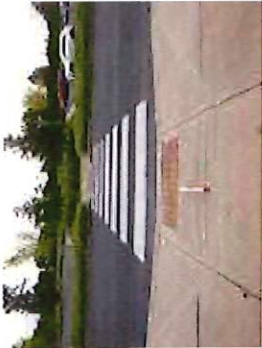
| Location | Solution / Description and Recommendation | Priority | Cost Estimate |
|---|---|---|---|
| <br><u>Multipurpose Fields - Southwest</u> | <p><b><i>Modify existing pathway</i></b></p> <p>There are no compliant curb cuts serving on the west side of the park drive to access the multipurpose fields and picnic shelter. The running slopes for the 2 curb cuts from the south parking have running slopes of 10% and 13%.</p> <p>Provide at least 1 accessible pedestrian crossing with compliant curb cut from the south parking lot to the sidewalk west of the park drive. Install, preferably, a blended transition not to exceed a running slope of 5% or a curb cut not to exceed a running slope of 2.08%.</p> <p>When the sidewalk to the west of the park drive is altered, replace the existing curb cuts with compliant curb cuts or, preferably, blended transitions.</p> <p>Reference: ADA 402<br/>Photo: MulberryFields-075<br/>Record #: 75<br/>Cost Note: Estimate to remove concrete curb cut; and install blended transition.</p> | Priority 2 - Serious | \$4,000 |

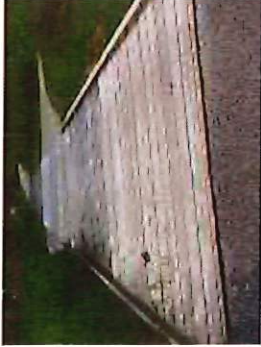
| Location | Solution / Description and Recommendation | Priority | Cost Estimate |
|---|---|---|---|
| | <b><i>Correct changes in level/openings for accessible route</i></b><br>There is a change in level greater than 1/2 inch at the transition between the asphalt park path and the boardwalk section.<br>Patch and fill the asphalt park path and, possibly, bevel the boards at the boardwalk to provide a smooth transition between the surfaces. The change in level should not exceed 1/4 inch vertical or 1/2 inch beveled.<br><br>Reference: ADA 302.3, 303, 403.4<br>Photo: MulberryFields-020<br>Record #: 63<br>Cost Note: Estimate to install silicone joint sealant x 20 linear ft. | Priority 3 - Moderate | \$200 |

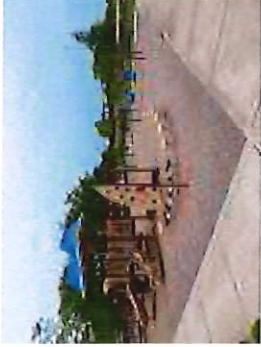
| Location | Solution / Description and Recommendation | Priority | Cost Estimate |
|---|---|---|---|
| | <b><i>Modify accessible route to playground/play components</i></b><br>The accessible point of entry into the playground is at the far north end of the playground requiring people with mobility impairments to travel a further distance to enter and exit the play surface area.<br>Consider installing an accessible point of entry on the more frequently used south side of the playground. Install, preferably, a blended transition not to exceed 5% or a curb cut not to exceed 6.25%.<br><br>Reference: ADA 206.2.17<br>Photo: MulberryFields-053<br>Record #: 67<br>Cost Note: Estimate to remove section of concrete and install concrete blended transition. | Priority 3 - Moderate | \$4,000 |

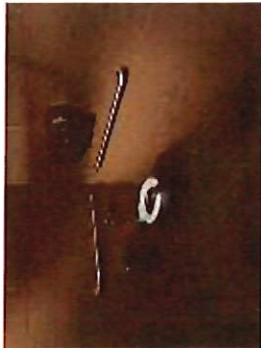
| Location | Solution / Description and Recommendation | Priority | Cost Estimate |
|---|---|---|---|
| | <b>Raise/lower toilet paper dispenser</b> | Priority 2 -<br>Serious | \$150 |
| | The toilet paper dispenser is mounted 5 inches above the side grab bar obstructing the use of the grab bar. | | |

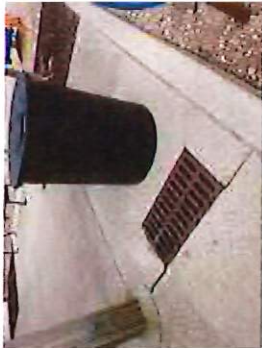
| Location | Solution / Description and Recommendation | Priority | Cost Estimate |
|---|---|---|---|
| | <b>Replace grate(s) along accessible route</b> | Priority 3 -<br>Moderate | \$250 |
| | The drain grate in the concrete surface at the picnic shelter has openings greater than 1/2 inch diameter. | | |

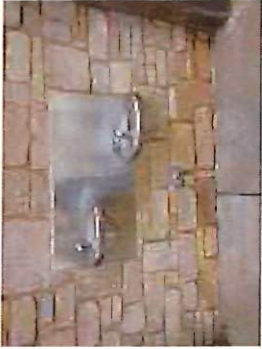
| Location | Solution / Description and Recommendation | Priority | Cost Estimate |
|---|---|---|---|
| | <b><i>Provide cane detection at drinking fountain</i></b><br>Both the high and low drinking fountains protrude from the wall without cane detection for people with visual impairments.<br>Lower the wheelchair accessible drinking fountain and consult with the drinking fountain manufacturer to determine if a conversion support or apron is available to mount under the high drinking fountain to make it cane detectable at maximum 27 inches above the finish floor. Alternatively, install a vertical panel or other furnishing adjacent to the drinking fountain to provide cane detection.<br><br>The wheelchair accessible unit shall be positioned for a forward approach with knee clearance a minimum 27 inches above the finish floor (and be cane detectable at 27 inches) and a spout height of 36 inches maximum. The standing unit shall have spout height 38 to 43 inches above the finish floor. | Priority 3 - Moderate | \$200 |

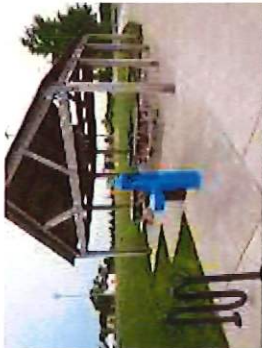
| Location | Solution / Description and Recommendation | Priority | Cost Estimate |
|---|---|---|---|
| | <b><i>Configure picnic area for clear floor space around picnic tables</i></b> | Priority 2 -<br>Serious | \$1,150 |
| | There are 4 standard and 1 accessible picnic tables serving the picnic shelter. | | |

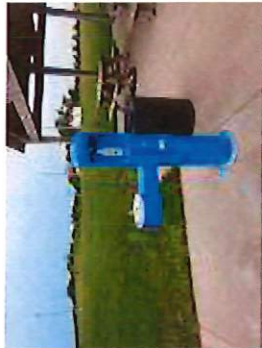
| Location | Solution / Description and Recommendation | Priority | Cost Estimate |
|---|---|---|---|
| | <b><i>Add/replace existing drinking fountain with high-low unit</i></b> | Priority 3 -<br>Moderate | \$3,000 |
| | There is a wheelchair accessible drinking fountain with bottle filler and dog bowl set back from the main park path and picnic shelter. The leading bottom edge is 27 1/2 inches above the ground surface and lacks cane detection for people with visual impairments. There is no high standing drinking fountain in the proximity for people who have difficulty bending or stooping. | | |

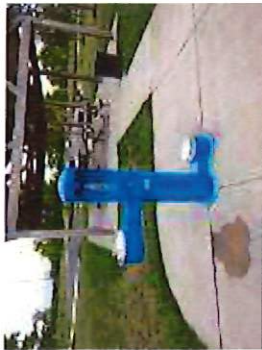
| Location | Solution / Description and Recommendation | Priority | Cost Estimate |
|---|---|---|---|
| | <p>Picnic Shelter South of Circle Drive</p> <p><b>Add/replace existing drinking fountain with high-low unit</b></p> <p>There is a wheelchair accessible drinking fountain with bottle filler and dog bowl set back from the main park path and picnic shelter. The leading bottom edge is 27 1/2 inches above the ground surface and lacks cane detection for people with visual impairments. There is no high standing drinking fountain in the proximity for people who have difficulty bending or stooping.</p> <p>Install a high drinking fountain in the proximity for people who have difficulty bending or stooping. The standing unit shall have spout height 38 to 43 inches above the finish floor.</p> <p>When the existing wheelchair accessible drinking fountain is replaced, install with a high-low combination unit in order to provide both a wheelchair accessible height fountain and a standing height fountain. The wheelchair accessible unit shall be positioned for a forward approach with knee clearance a minimum 27 inches above the finish floor (and be cane detectable at 27 inches) and a spout height of 36 inches maximum. The standing unit shall have spout height 38 to 43 inches above the finish floor.</p> <p>Reference: ADA 211, 602</p> <p>Photo: MulberryFields-072</p> <p>Record #: 74</p> <p>Cost Note: Estimate to install high standing drinking fountain.</p> | Priority 3 - Moderate | \$3,000 |

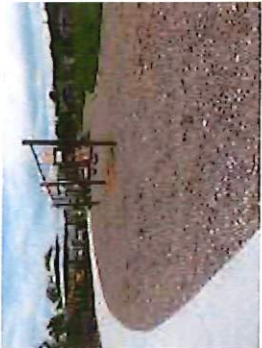
| Location | Solution / Description and Recommendation | Priority | Cost Estimate |
|---|---|---|---|
| | The playground is surfaced with engineered wood fiber. The undulation of the surface material exceeds the maximum allowable 6.25% slope for the accessible route to play components and the maximum allowable 2.08% clear floor space at play components. | Priority 2 - Serious | \$3,500 |

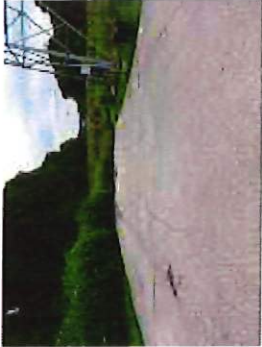
| Location | Solution / Description and Recommendation | Priority | Cost Estimate |
|---|---|---|---|
| | <p><b>Parking</b></p> <p><b><i>Stripe accessible parking space and access aisle</i></b></p> <p>There are an estimated 13 standard parking spaces. There are no designated accessible parking spaces.</p> <p>Stripe for a minimum of one van accessible parking space (132 inches wide) and access aisles (60 inches wide). Alternatively, all accessible parking spaces could be striped as universal with 96 inch width for each accessible space and 96 inch width for each access aisle. Install sign designating the accessible parking space including the International Symbol of Accessibility. Signs identifying van parking spaces shall contain the designation "van accessible." Signs shall be 60 inches minimum above the finish floor or ground surface measured to the bottom of the sign.</p> <p>Reference: ADA 502<br/>Photo: StarkeyNaturePark-003<br/>Record #: 94<br/>Cost Note: Estimate to stripe accessible parking space and access aisle; and install parking sign.</p> | Priority 1 - Critical | \$1,000 |

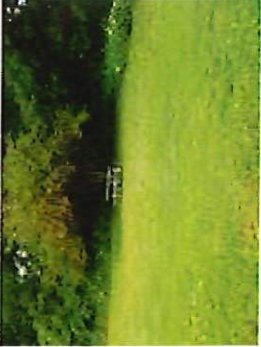
| Location | Solution / Description and Recommendation | Priority | Cost Estimate |
|---|---|---|---|
| | <p><b>Open Picnic Area</b></p> <p><b><i>Provide picnic units with mobility features</i></b></p> <p>There is 1 standard picnic table in the open picnic area. There is no accessible route to the open picnic area. The current path is through grass.</p> <p>Design a new accessible open space picnic area such that at least 20 percent, but not less than 2, of the total number of units are accessible and placed on an accessible route with a minimum 36 inch clear floor space around all usable sides. Each accessible picnic table shall have at least one wheelchair seating space a minimum of 30 by 48 inches for each 24 linear feet of usable space around the perimeter of a tabletop. Knee clearance must be at least 30 inches wide and 8 inches deep at 27 inches above the ground surface. Toe clearance must be at least 30 inches wide and 17 inches deep and extend at least 9 inches above the ground surface. Table tops shall be 28 to 34 inches above the floor or ground surface.</p> <p>Reference: ABAS-Outdoor F245.2, 1011<br/>Photo: StarkeyNaturePark-010<br/>Record #: 96<br/>Cost Note: Estimate for open space picnic area with 2 accessible tables, new asphalt path 30 ft x 6 ft.</p> | Priority 1 - Critical | \$6,500 |

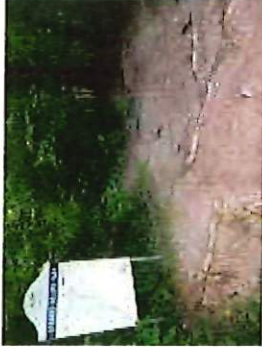
| Location | Solution / Description and Recommendation | Priority | Cost Estimate |
|---|---|---|---|
| | <b><i>Provide accessible trail</i></b><br><br>There are no designated accessible pedestrian recreation trails at this site. The existing trails are a combination of natural surface and grass. There are tread obstacles including exposed roots and rocks. Some trails have stairs.<br><br>Develop a comprehensive trail plan to design at least one trail at this site that gives the programmatic experience of trail use and includes the prominent features by which visitors come to this site to see. It may be necessary to install an accessible outdoor trail surface such as a 50-50 mix of crushed limestone with 50% stone that is sized smaller than 1/4 inch and 50% dust.<br><br>Reference: ADA Program Access 35.149; ABAS 1017<br>Photo: StarkeyNaturePark-014<br>Record #: 97<br>Cost Note: Estimate for design services. | Priority 1 -<br>Critical | \$4,000 |

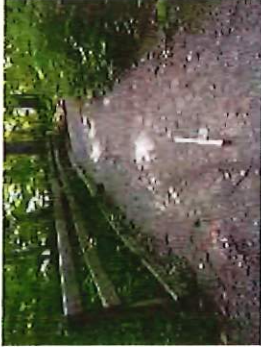
| Location | Solution / Description and Recommendation | Priority | Cost Estimate |
|---|---|---|---|
| | <p>The main pedestrian trail is surfaced with crushed stone. There are sections of the trail to the outdoor classroom with a running slope over 8% and up to 14%. The center of the trail tread has a rut running through it due to storm run off and erosion. The surface material is washed out at the approaches to the footbridges resulting in changes in level up to 3 inches from the trail to the wood surface.</p> <p>Evaluate the existing trail and install erosion controls to maintain an accessible trail to the outdoor classroom. The accessible trail should not exceed a running slope of 8.33% for a maximum distance of 200 ft. The accessible trail is permitted to have a running slope from 8.33% to 10% for a distance of 30 ft; or up to 12% for 10 ft. Install additional trail surface with crushed stone to maintain a smooth transition between the trail surface and the foot bridge. It may be necessary to install an accessible outdoor trail surface such as a 50-50 mix of crushed limestone with 50% stone that is sized smaller than 1/4 inch and 50% dust.</p> <p>Reference: ADA Program Access 35.149; ABAS 1017</p> <p>Photo: ZionNatureSanctuary-026</p> <p>Record #: 128</p> <p>Cost Note: Estimate for design services.</p> | Priority 1 - Critical | \$4,000 |

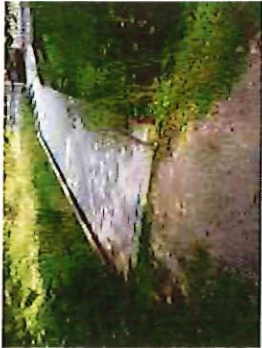
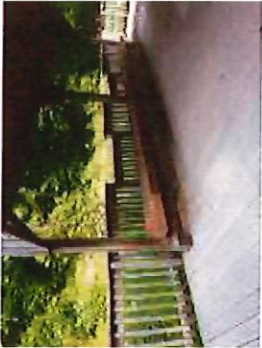
| Zion Nature Sanctuary - Outdoor Classroom | | Location | Solution / Description and Recommendation | Priority | Cost Estimate |
|---|---|---|---|---|---|
| | | Trail at Outdoor Classroom | <p><b>Correct changes in level/openings for accessible route</b></p> <p>The crushed stone surface material is washed out at the approach to the wood boardwalk to the outdoor classroom resulting in a change in level and drop off at the sides.</p> <p>Replenish the crushed stone surface material and install so the trail tread and boardwalk consistently maintain the same width. It may be necessary to install additional edge protection to eliminate any drop off at the approach to the boardwalk. Provide a smooth transition between the crushed stone trail surface and the wood boardwalk. It may be necessary to install an accessible outdoor trail surface such as a 50-50 mix of crushed limestone with 50% stone that is sized smaller than 1/4 inch and 50% dust.</p> <p>Reference: ADA 302.3, 303, 403.4</p> <p>Photo: ZionNatureSanctuary-016</p> <p>Record #: 129</p> <p>Cost Note: Estimate to install 50-50 mix of crushed limestone and dust for 25 sq ft and compact.</p> | Priority 2 - Serious | \$2,500 |
| | | Outdoor Classroom | <p><b>Provide accessible viewing area</b></p> <p>There are long benches that have been placed in front of the guard railing at the outdoor classroom, obstructing the sections of railing that have been lowered to serve as accessible viewing locations. The placement of the existing benches does not facilitate outward viewing from the covered classroom.</p> <p>Evaluate alternative placement of benches to facilitate viewing from the covered shelter. Provide an accessible viewing area with a minimum 36 x 48 inch clear floor space at each distinct viewing location. The viewing space must be free and clear of obstructions between 32 and 51 inches above the ground and must extend the full width of the clear floor space.</p> <p>Reference: ABAS-Outdoor F246, 1015</p> <p>Photo: ZionNatureSanctuary-018</p> <p>Record #: 130</p> <p>Cost Note: Remove the existing long benches; and install bench alternatives.</p> | Priority 2 - Serious | \$4,500 |

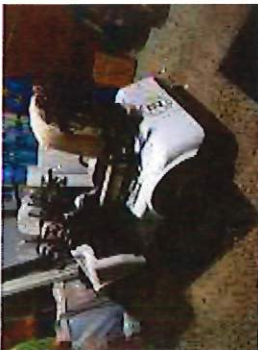
| Location | Solution / Description and Recommendation | Priority | Cost Estimate |
|---|---|---|---|
| | While the golf course provides a Solo Rider, single rider adaptive golf cart, staff state that it is not requested often and those that use it complain it is too fast. There is no information about the availability of the single rider golf cart at the clubhouse or on the golf course web site. | Priority 1 - Critical | |

| Location | Solution / Description and Recommendation | Priority | Cost Estimate |
|---|---|---|---|
| | Consult with the Solo Rider manufacturer on the need to adjust the hand controls relative to speed. | | |

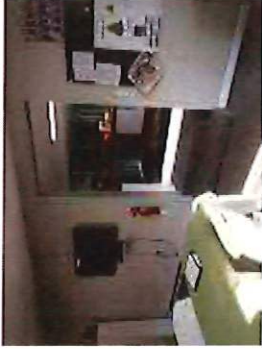
| Location | Solution / Description and Recommendation | Priority | Cost Estimate |
|---|---|---|---|
| | <b><u>Install handrails at stairs</u></b> | | |
| | There are 2 steps between the main level of the clubhouse and the lower level of the meeting/dining space. The stairs lack handrails. | | |

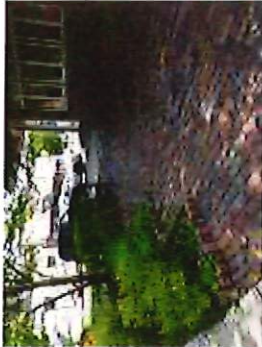
| Location | Solution / Description and Recommendation | Priority | Cost Estimate |
|---|---|---|---|
| <br><u>Park</u> | <b><i>Correct changes in level/openings for accessible route</i></b> <p>The pocket park is surfaced with brick pavers. There are openings and changes in level greater than 1/2 inch throughout the surface area and at the transitions to the concrete perimeter sidewalk. There are also heaves in the brick paver surface that exceed a 5% running slope and 2.08% cross slope.</p> <p>Adopt a cyclical maintenance schedule to remove the pavers, level the subsurface, and reinstall the pavers to provide a smooth, consistent, accessible surface. Openings in the surface should not exceed 1/2 inch diameter. Changes in level in the surface should not exceed 1/4 inch vertical or 1/2 inch beveled. The paver path should not exceed a running slope of 5% and a cross slope of 2.08%.</p> <p>Alternatively, consider removing the existing pavers and replacing the path with a lower maintenance surface like stamped concrete that replicates the paver look without the openings and changes in level in the surface area.</p> <p>Reference: ADA 302.3, 303, 403.4</p> <p>Photo: VillageCorner-003</p> <p>Record #: 106</p> <p>Cost Note: Estimate to remove the pavers, level the subsurface, and reinstall the pavers 1,800 sq ft.</p> | Priority 2 -<br>Serious | \$18,000 |

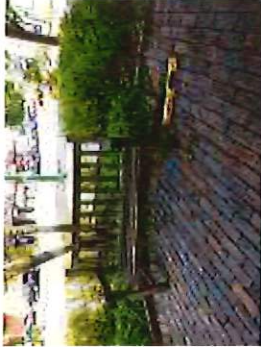
| Location | Solution / Description and Recommendation | Priority | Cost Estimate |
|---|---|---|---|
| <br><u>Park</u> | <b><i>Provide clear ground space adjacent to bench</i></b> <p>There are 2 outdoor benches in the sitting area set on the brick pavers. The benches lack the minimum clear ground space adjacent for wheelchair seating. The bench on the left has a slope from 4% to 7% in the space for adjacent wheelchair seating.</p> <p>As the pavers and subsurface are leveled, select a space for the benches and adjacent wheelchair seating with a slope not to exceed 2.08% in all directions. As benches are installed, repaired or replaced, ensure a minimum of 20 percent are accessible, adjacent to the accessible route with clear ground space for wheelchair seating. For benches, provide styles with back supports and at least one armrest along with a minimum clear ground space 36 x 48 inches positioned near the bench with one side of the space adjoining an accessible route, outdoor recreation access route or trail. The clear ground space shall not overlap the accessible route or trail, or another clear ground space.</p> <p>Reference: ABAS-Outdoor 1011</p> <p>Photo: VillageCorner-007</p> <p>Record #: 107</p> <p>Cost Note: Estimate bundled with project to level pavers.</p> | Priority 2 -<br>Serious | |

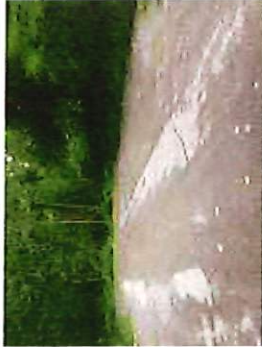
| Location | Solution / Description and Recommendation | Priority | Cost Estimate |
|---|---|---|---|
| | <p><u>Parking</u></p> <p><b><i>Stripe accessible parking space and access aisle</i></b></p> <p>There are an estimated 10 parking spaces at the asphalt paved parking lot. There is no designated accessible parking space.</p> <p>Stripe for a minimum of one van accessible parking space (132 inches wide) and access aisle (60 inches wide). Alternatively, all accessible parking spaces could be striped as universal with 96 inch width for each accessible space and 96 inch width for each access aisle. Install a sign designating the accessible parking spaces including the International Symbol of Accessibility. Signs identifying van parking spaces shall contain the designation "van accessible." Signs shall be 60 inches minimum above the finish floor or ground surface measured to the bottom of the sign.</p> <p>Reference: ADA 502<br/>Photo: WetlandReserve-004<br/>Record #: 108<br/>Cost Note: Estimate to stripe for accessible parking space and access aisle; install sign and post.</p> | Priority 1 - Critical | \$1,000 |

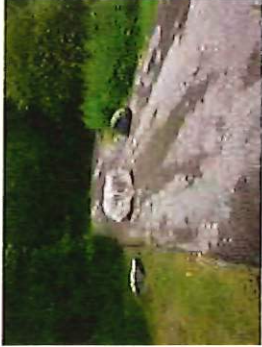
| Location | Solution / Description and Recommendation | Priority | Cost Estimate |
|---|---|---|---|
| | <p><u>Program Access</u></p> <p><b><i>Relocate program, service, activity or experience to an accessible location</i></b></p> <p>At the time of the accessibility assessment, the parking lot had been closed off for public use.</p> <p>Nature watching is permitted at this undeveloped site. There are no site amenities. There is no accessible route connecting a site arrival point to locations where nature watching could take place.</p> <p>If nature watching is to be permitted at this site, provide accessible opportunities for people with disabilities including an accessible site arrival point/parking and connection to an accessible route. Relocate programs, services, and activities such as organized hikes, interpretive nature talks, and outdoor recreation programs to an accessible location until such time that the park is made accessible to fully include visitors with disabilities.</p> <p>Reference: ADA Program Access 35.149, 35.150<br/>Photo: WetlandReserve-002<br/>Record #: 109<br/>Cost Note: Programs.</p> | Priority 1 - Critical | |

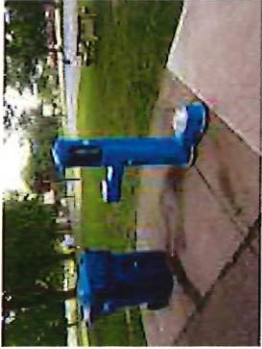
| Location | Solution / Description and Recommendation | Priority | Cost Estimate |
|---|---|---|---|
| | <p>There is a wheelchair accessible drinking fountain with bottle filler and dog bowl set back from the main circulation route. The leading bottom edge is 27 1/2 inches above the ground surface and lacks cane detection for people with visual impairments. There is no high standing drinking fountain in the proximity for people who have difficulty bending or stooping.</p> <p>Install a high drinking fountain in the proximity for people who have difficulty bending or stooping. The standing unit shall have spout height 38 to 43 inches above the finish floor.</p> <p>When the existing wheelchair accessible drinking fountain is replaced, install with a high-low combination unit in order to provide both a wheelchair accessible height fountain and a standing height fountain. The wheelchair accessible unit shall be positioned for a forward approach with knee clearance a minimum 27 inches above the finish floor (and be cane detectable at 27 inches) and a spout height of 36 inches maximum. The standing unit shall have spout height 38 to 43 inches above the finish floor.</p> | | |
| Reference: | ADA 211, 602 | | |
