Mid-Block Crosswalk Evaluation

CR 975 E. and Oak Ridge Drive Evaluation and Recommendation

November 15, 2021

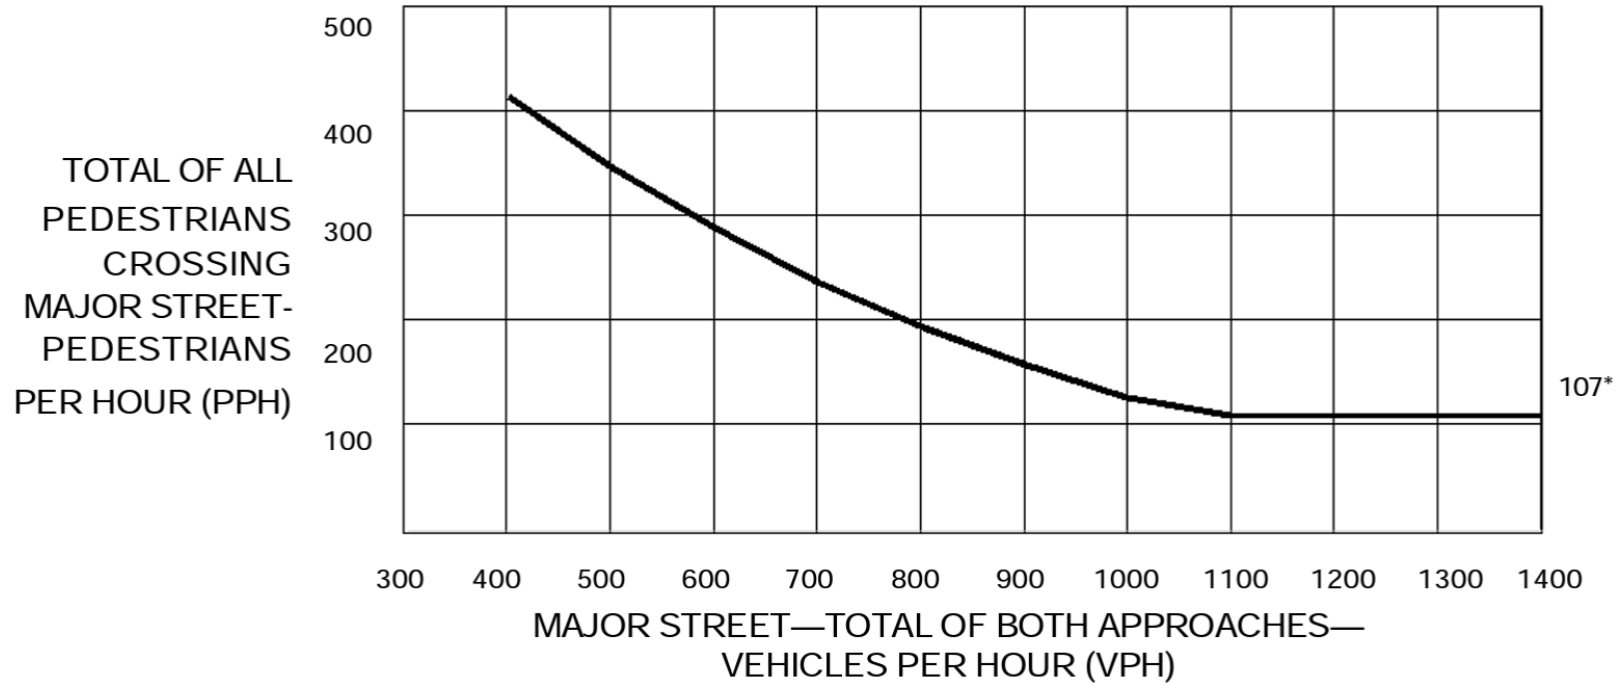
Figure 4C-5. Warrant 4, Pedestrian Four-Hour Volume

IMUTCD pedestrian signal warrant

*Note: 107 pph applies as the lower threshold volume.

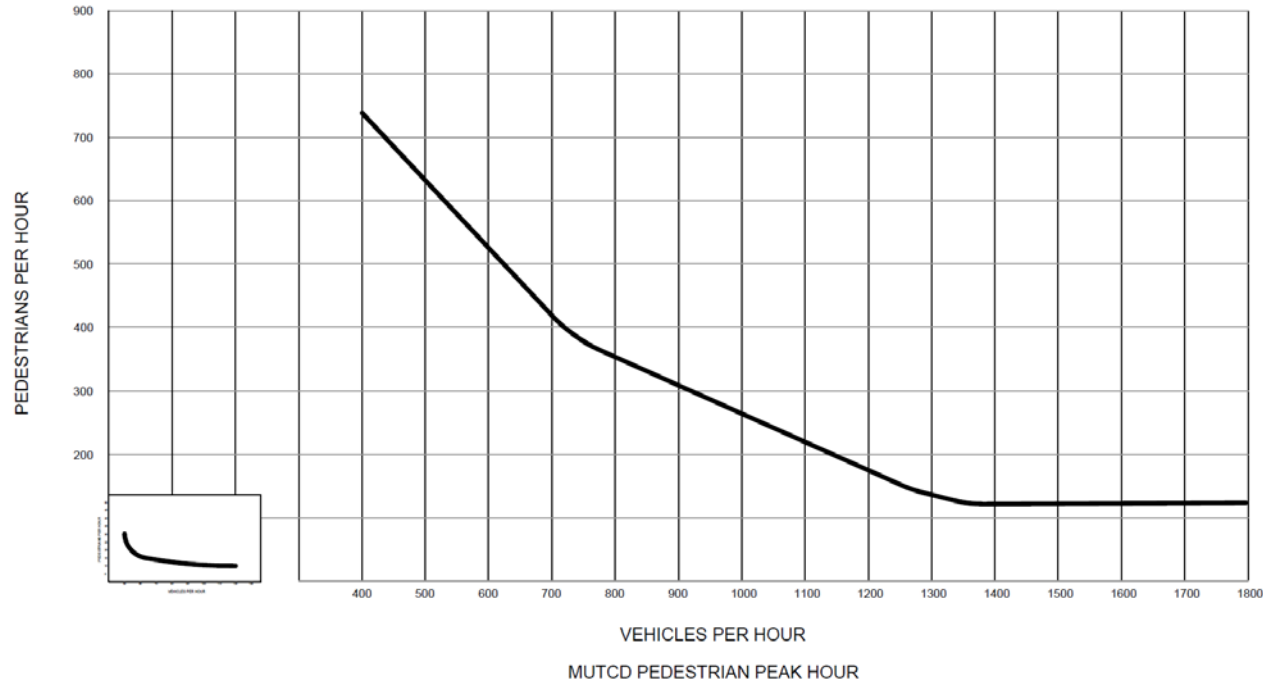
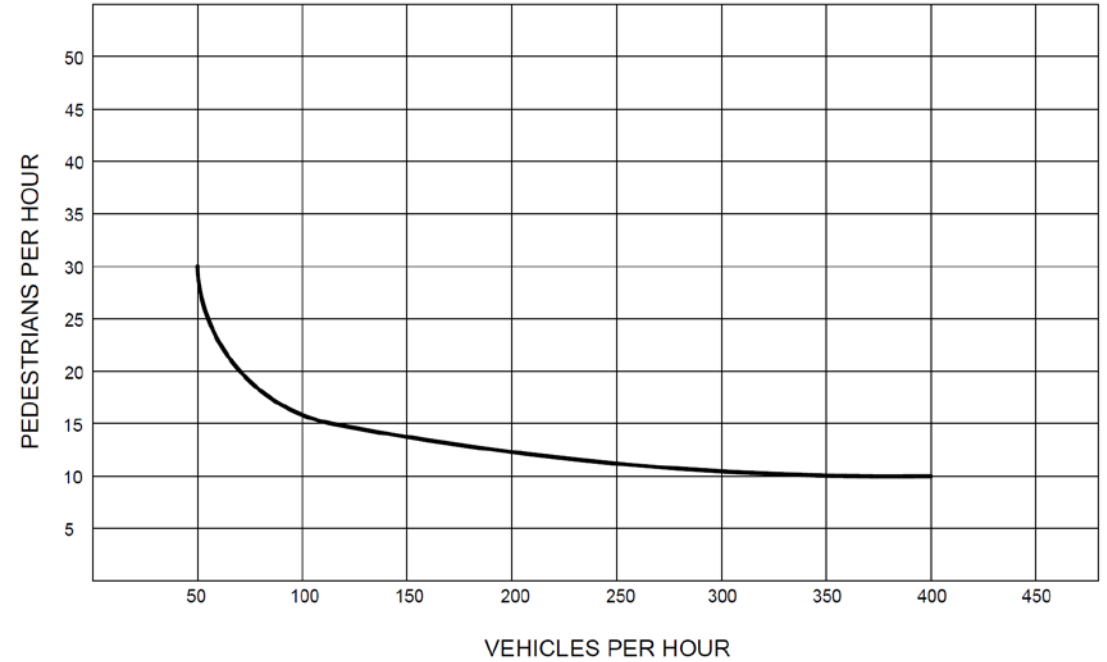
Minimum 10 pedestrians per peak hour
On or above the curve advances

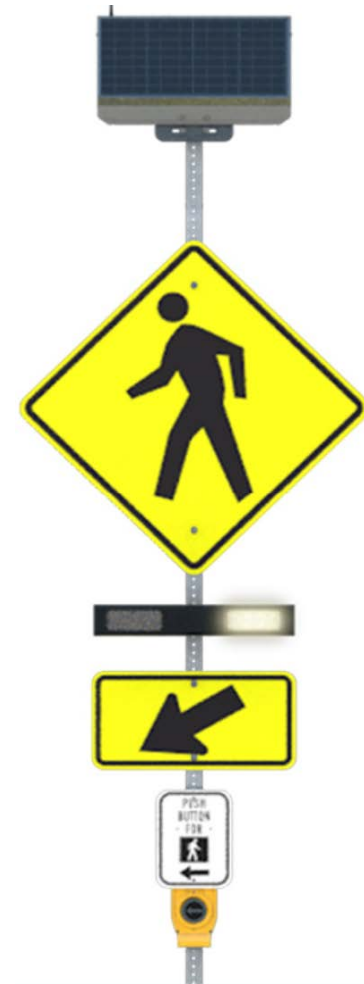
Rapid Rectangular Flashing Beacon (RRFB)

Currently three in use within town's jurisdiction

- Oak St. & 5th St. (town project)
- CR 400 S. at Hampshire Subdivision
- CR 500 S. at Hampshire & Pemberton Subdivisions (Plan Commission commitment by developers)

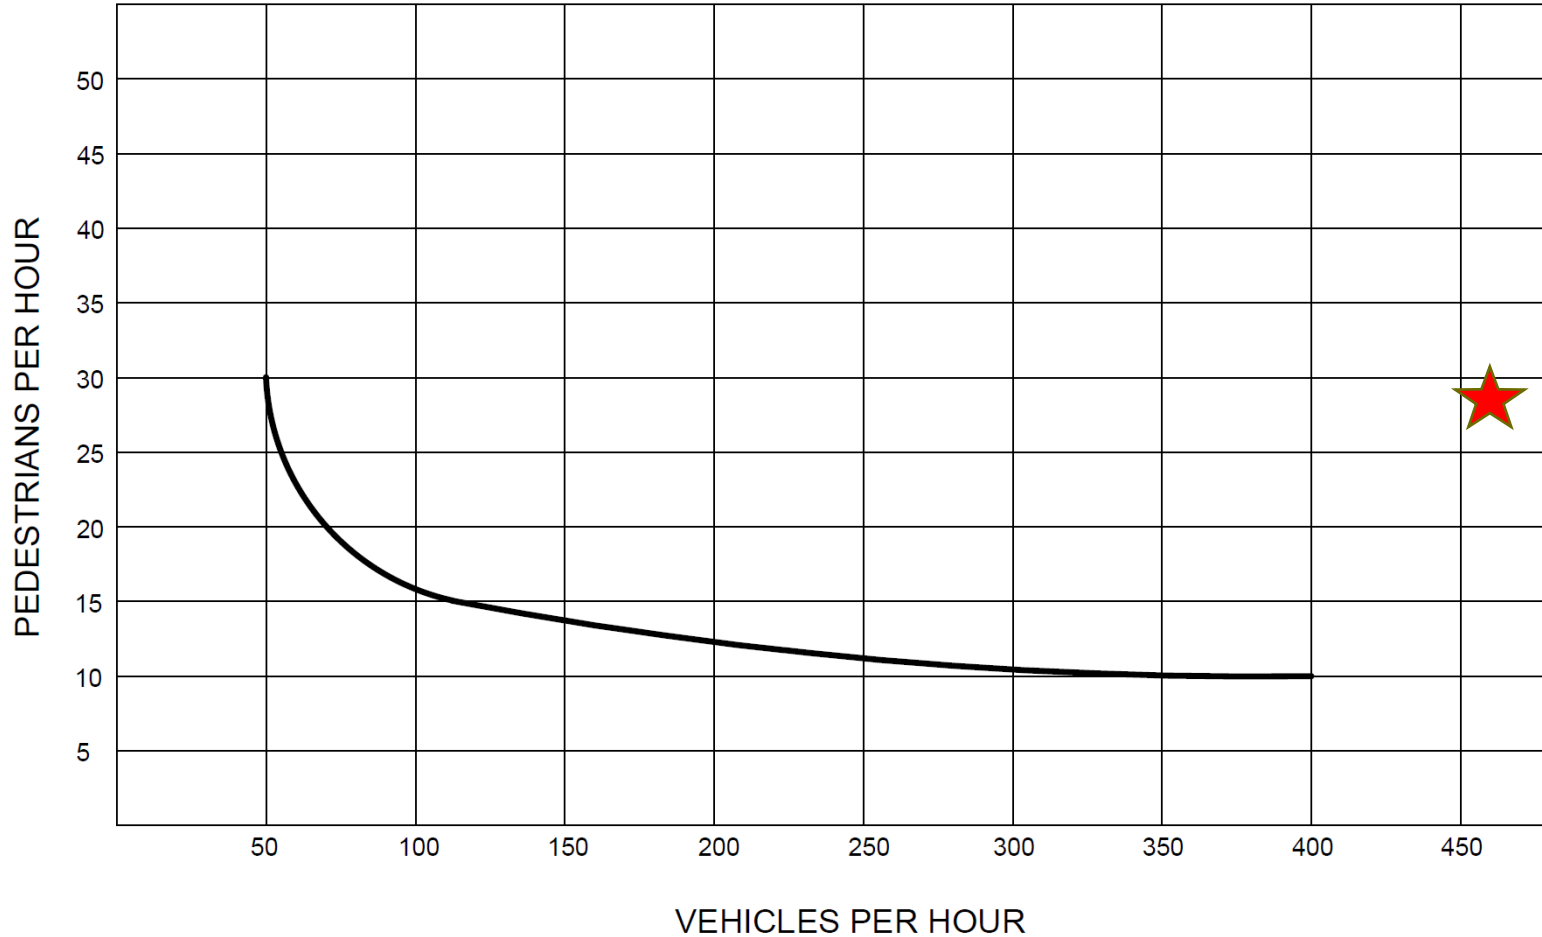
Data Analysis

27 peds / hour
460 vehicles / hour

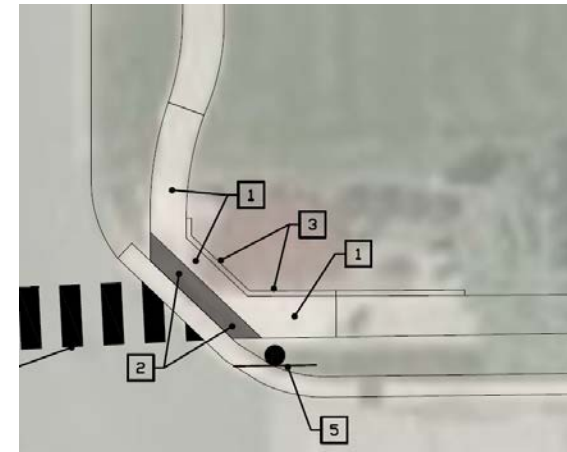
Detailed Site-Specific Design

- KEY NOTES**
- 1 CONCRETE SIDEWALK (SEE SHEET C3.0)
 - 2 DETECTABLE WARNING SURFACE
 - 3 LANDSCAPE BLOCK RETAINING WALL (RE-USE EXISTING BLOCKS)
 - 4 2'x6' THERMOPLASTIC STRIPING SPACED 4' O.C.
 - 5 SOLAR POWERED RRFB SIGN (SEE SHEETS C2.1 & C3.0)

On CR 975 East at its intersection with Oak Ridge Dr. on the north leg
