**RESOLUTION NO. 2025-13**

**A RESOLUTION OF THE ZIONSVILLE TOWN COUNCIL APPROVING AN UPDATE  
TO THE TOWN OF ZIONSVILLE AMERICANS WITH DISABILITIES ACT  
TRANSITION PLAN**

Accessibility Assessment Conditions Report

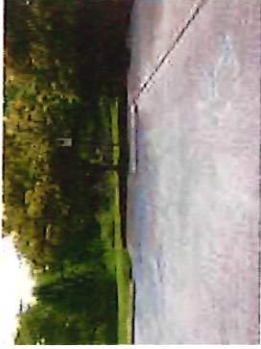
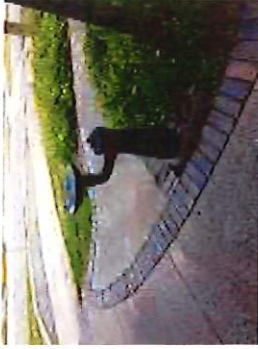
| Location | Solution / Description and Recommendation | Priority | Cost Estimate |
|---|---|---|---|
| <p>The path from the parking area to the monumental landscape is surfaced with brick pavers. There are openings and changes in level greater than 1/2 inch throughout the surface area and at the transitions to the primary path surfaced with exposed aggregate.</p> <p>Adopt a cyclical maintenance schedule to remove the pavers, level the subsurface, and reinstall the pavers to provide a smooth, consistent, accessible surface. Openings in the surface should not exceed 1/2 inch diameter. Changes in level in the surface should not exceed 1/4 inch vertical or 1/2 inch beveled.</p> <p>Alternatively, consider removing the existing pavers and replacing the path with a lower maintenance surface like stamped concrete that replicates the paver look without the openings and changes in level in the surface area.</p> | | | |

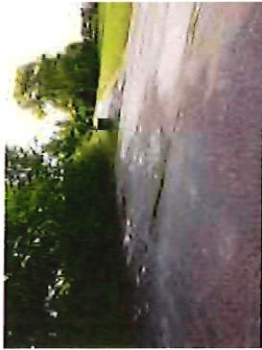
| Location | Solution / Description and Recommendation | Priority | Cost Estimate |
|---|---|---|---|
| | <p>There are an estimated 7 parking spaces at the asphalt paved parking lot. There is no designated accessible parking space.</p> <p>Stripe for a minimum of one van accessible parking space (132 inches wide) and access aisle (60 inches wide). Alternatively, all accessible parking spaces could be striped as universal with 96 inch width for each accessible space and 96 inch width for each access aisle. Install a sign designating the accessible parking spaces including the International Symbol of Accessibility. Signs identifying van parking spaces shall contain the designation "van accessible." Signs shall be 60 inches minimum above the finish floor or ground surface measured to the bottom of the sign.</p> | | |

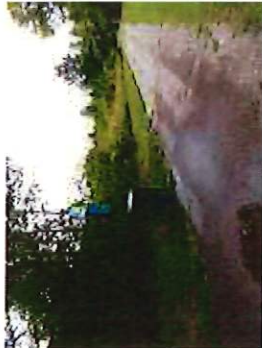
| Location | Solution / Description and Recommendation | Priority | Cost Estimate |
|---|---|---|---|
| | <b><i>Lower/relocate dog waste bag dispenser</i></b> | Priority 3 -<br>Moderate | \$60 |
| | <p>While the trash receptacle is set on the accessible route, the dog waste bag dispenser is mounted on a post on the back side of the unit. The outlet exceeds 48 inches above the ground surface with a 19 inch reach over the trash receptacle, outside of the accessible reach range.</p> <p>Lower the dog waste bag dispenser on the post. The outlet for the dispenser should not exceed an unobstructed reach of 48 inches above the ground surface. If an obstructed reach over the trash receptacle is necessary, the outlet should not exceed 44 inches above the ground surface with a maximum depth of 25 inches.</p> <p>Reference: ADA 308<br/>Photo: CarterStationPark-002<br/>Record #: 7<br/>Cost Note: Estimate to lower dog waste bag dispenser on post.</p> | | |

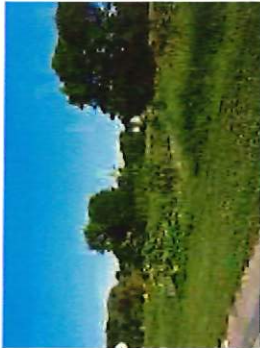
| Location | Solution / Description and Recommendation | Priority | Cost Estimate |
|---|---|---|---|
| | <b><i>Provide accessible route and accessible features at garden</i></b> | | |
| | There is no accessible route to the community garden, garden plots, or amenities serving the garden like water and storage. There are no accessible garden plots. The current path is through grass. | Priority 1 - Critical | \$3,000 |

| Location | Solution / Description and Recommendation | Priority | Cost Estimate |
|---|---|---|---|
| | Extend the main park path to connect the site arrival point/accessible parking space to the community garden. Designate at least 5% of each type of garden plot as accessible with accessible surface around all sides, a minimum 36 inch clear width for the accessible route, and 60 x 60 inch turning space. Consider providing a variety of accessible garden plots such as raised beds, containers and vertical gardens as alternatives to the ground level garden plots. Locate amenities like water and storage on the accessible route. | | |

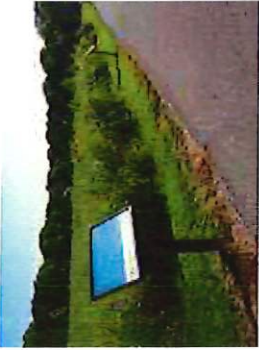
| Location | Solution / Description and Recommendation | Priority | Cost Estimate |
|---|---|---|---|
| | <b>Interpretive Waysides along Trail/Shared Use Path</b><br><br><b>Provide interpretive wayside content in multiple modes including text, graphics, audio and tactile opportunities</b><br><br>Interpretive waysides are located throughout the park. Many are set back in the landscape or grass, lacking connection to an accessible route and clear ground space for a forward approach to read the content. The text may be too small for the viewing distance. The interpretive content relies heavily on text and graphics that may not be accessible to people with low vision or people with cognitive impairments. The content is not provided in an aural or tactile mode.<br><br>Develop interpretive wayside content to be provided in multiple modes including text, graphics, aural, audio and tactile experiences. Waysides should be installed on the accessible route with clear floor space for a forward approach at the fixture. Text is recommended as sans serif at a font sized appropriately for the viewing distance. Consider developing a tactile map or model to orientate visitors to the site and other tactile features with significant relevance to the story. The interpretive content and tactile features should be accompanied by an audio description component.<br><br>Reference: ADA Program Access 35.149<br>Photo: ElmStGreen-023<br>Record #: 21<br>Cost Note: Estimate to develop interpretive wayside plan. | Priority 1 - Critical | \$6,000 |

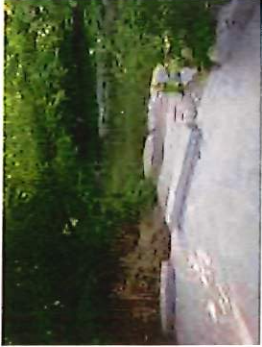
| Location | Solution / Description and Recommendation | Priority | Cost Estimate |
|---|---|---|---|
| <p><u>Kayak Launch</u><br/> <b>Provide accessible canoe/kayak launch</b><br/> While this location is designated as a canoe/kayak launch, the concrete edge protection for the bank fishing area is a barrier to launch into the water.<br/> Provide accessible route and location for canoe/kayak launch.<br/> Reference: ADA Program Access 35.149<br/> Photo: ElmStGreen-041<br/> Record #: 23<br/> Cost Note: Estimate for design services.</p> | | Priority 1 - Critical | \$3,000 |

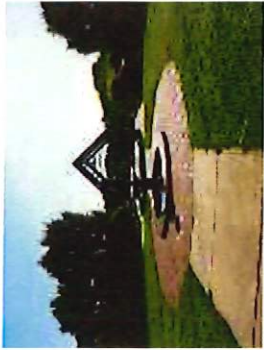
| Location | Solution / Description and Recommendation | Priority | Cost Estimate |
|---|---|---|---|
| | <b><i>Correct changes in level/openings for accessible route</i></b> | | |

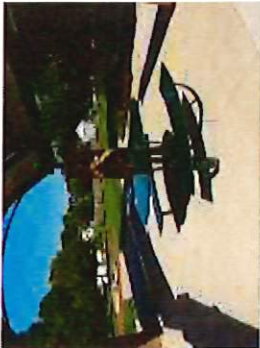
| Location | | Solution / Description and Recommendation | | Priority | Cost Estimate |
|---|--|---|--|---|---|
| | | <b>Configure picnic area for clear floor space around picnic tables</b> | | | |
| | | There is 1 accessible non-fixed picnic table serving the shelter. | | | |

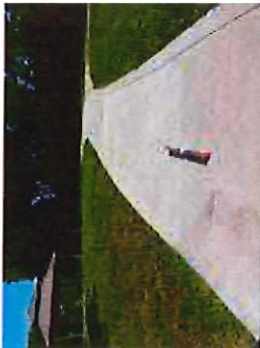
| Elm Street Green - Picnic Shelter at Playground | | Location | Solution / Description and Recommendation | Priority | Cost Estimate |
|---|---|---|---|---|---|
| | <b><i>Modify existing pathway</i></b> | | | | |
| | | | The concrete park path to the picnic shelter has a running slope over 5% and up to 8% for a distance of 20 ft triggering the requirement for a ramp including handrails and landings. | | |

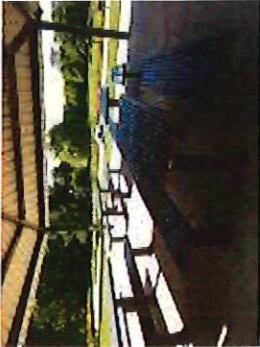
| Location | Solution / Description and Recommendation | Priority | Cost Estimate |
|---|---|---|---|
| | <p><u>Picnic Shelter at Playground</u></p> <p><b>Configure picnic area for clear floor space around picnic tables</b></p> <p>There are 4 accessible fixed picnic tables serving the shelter.</p> <p>Design a floor plan for the picnic shelter with placement of picnic tables. Configure the picnic area so that at least 20 percent, but not less than two accessible picnic tables have space for wheelchair seating at least 30 inches wide with knee clearance and a minimum 36 inch clear width around all usable sides of the table measured from the back edge of the bench.</p> <p>Reference: ABAS-Outdoor F245.2, 1011.2, 1011.4</p> <p>Photo: ElmStGreen-028</p> <p>Record #: 29</p> <p>Cost Note: Estimate to design floor plan for picnic shelter.</p> | <p>Priority 3 - Moderate</p> | <p>\$50</p> |

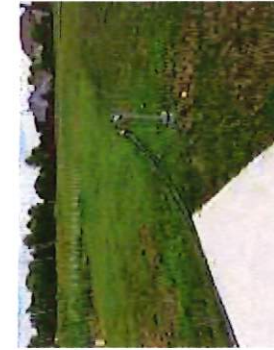
## Community Garden

### ***Provide clear ground space at outdoor water faucet/pump/hydrant***

Extend the existing concrete surface at the community garden to provide clear ground space for the water faucet that is 72 x 48 inches with the long side of the space adjoining or overlapping the accessible route, trail, or another clear ground space. Locate the space so that the water spout is 11 inches minimum and 12 inches maximum from the rear center of the long side of the space. Replace the faucet control with an accessible operating mechanism that does not require tight grasping, pinching, and twisting of the wrist or more than 5 lbs force to operate.

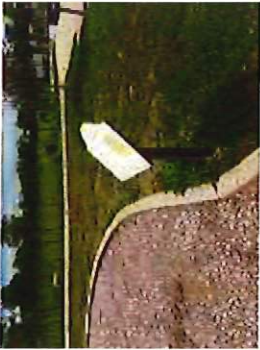
| Location | Solution / Description and Recommendation | Priority | Cost Estimate |
|---|---|---|---|
| <b>Locate interpretive wayside on accessible route</b> | | Priority 1 - Critical | \$6,000 |
| | <p>Interpretive waysides are located throughout the park and around the playground. Many are set back in the landscape or grass, lacking connection to an accessible route and clear ground space for a forward approach to read the content. The text may be too small for the viewing distance. The interpretive content relies heavily on text and graphics that may not be accessible to people with low vision or people with cognitive impairments. The content is not provided in an aural or tactile mode.</p> <p>Relocate the existing waysides to an accessible location. As a best practice, interpretive waysides are angled not to exceed 45 degrees and easily read from a seated position with viewing sightlines 43 to 51 inches above the ground surface and standing sightlines 48 to 67 inches above the ground.</p> <p>Develop interpretive wayside content to be provided in multiple modes including text, graphics, aural, audio and tactile experiences. Waysides should be installed on the accessible route with clear floor space for a forward approach at the fixture. Text is recommended as sans serif at a font sized appropriately for the viewing distance. Consider developing a tactile map or model to orientate visitors to the site and other tactile features with significant relevance to the story. The interpretive content and tactile features should be accompanied by an audio description component.</p> | | |

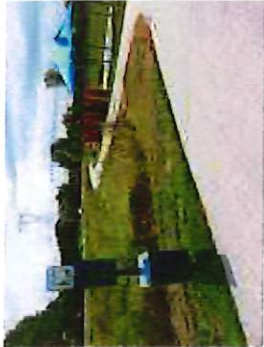
| Location | Solution / Description and Recommendation | Priority | Cost Estimate |
|---|---|---|---|
| <b>Provide orientation signage for shared use path</b> | | | |
| | A concrete and asphalt recreational trail/shared use path cuts through the park. The park trail connects to the Big 4 Rail Trail. There is no trailhead kiosk or posted objective information on the trail characteristics. | | |

| Location | Solution / Description and Recommendation | Priority | Cost Estimate |
|---|---|---|---|
| | Consider the installation of trailhead signage on the shared use path to provide visitors with orientation information on the current location, the route of the path, proximity to other streets and landmarks, and amenities. Similar to pedestrian recreation trails, information on the characteristics of the shared use path is helpful to visitors such as including the length of the trail or trail segment; surface type; average and minimum tread width; average and maximum running slope; and average and maximum cross slope. | | |
| | Information on the sign should also include accessible features like parking, restrooms, picnic areas, air stations, drinking fountains, street crossings, and locations where the accessible route may deviate from the shared use path. Consider a simple map design with high contrast between foreground and background, sans serif font, and textures for tactile orientation. | | |

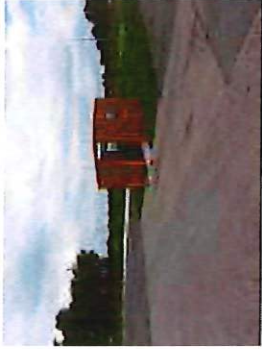
| Location | Solution / Description and Recommendation | Priority | Cost Estimate |
|---|---|---|---|
| <p><u>Parking</u><br/><b>Provide accessible portable toilet</b></p> <p>Park visitors must cross the vehicular traffic of the parking lot to access the portalet. Parked cars and wheel stops obstruct the clear width of the accessible route to the unit. The portalet is enclosed by a wood modesty fence.</p> <p>The toilet paper dispenser and soap/hand sanitizer dispenser in the Anytime Outhouse are mounted too high outside of the reach range.</p> <p>Consider striping a pedestrian crossing to the portalet with a preferred 60 inch clear width.</p> <p>Lower the toilet paper dispenser and soap/hand sanitizer dispenser not to exceed 48 inches above the finish floor. The outlet of the toilet paper dispenser shall be mounted within the reach range, 15-48 inches above the floor. The centerline of the dispenser shall be mounted 7-9 inches in front of the water closet. The space between the grab bar and projecting objects below and at the ends shall be 1½ inches minimum. The space between the grab bar and projecting objects above shall be 12 inches minimum.</p> <p>Reference: ADA 604<br/>Photo: HeritageTrailPark-004<br/>Record #: 31<br/>Cost Note: Estimate to stripe pedestrian crossing; lower toilet paper dispenser and soap/hand sanitizer dispenser in portalet.</p> | | Priority 3 - Moderate | \$850 |

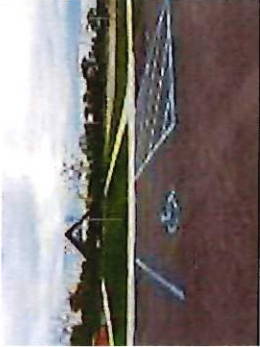
| Zionsville Parks and Recreation | | Accessibility Assessment Conditions Report | | |
|---|---|---|---|--|
| <div> </div> | <p><b><i>Restripe existing parking lot to include accessible parking spaces and access aisles</i></b></p> <p>There are 34 standard parking spaces and 3 designated accessible parking spaces. The pavement markings designating the accessible parking spaces and access aisles are inconsistently striped.</p> <p>For this size parking lot, only 2 accessible parking spaces are required. Evaluate the need to retain the additional accessible parking space. If the extra accessible parking space is eliminated, paint over the pavement markings with black.</p> <p>Restripe for a minimum of one van accessible parking space (132 inches wide), one car accessible parking space, and access aisles (60 inches wide). Alternatively, all accessible parking spaces could be striped as universal with 96 inch width for each accessible space and 96 inch width for each access aisle.</p> <p>Reference: ADA 502</p> <p>Photo: HeritageTrailPark-003</p> <p>Record #: 30</p> <p>Cost Note: Estimate to restripe accessible parking space and access aisle x 2.</p> | <p>Priority 4 - Minor</p> | \$1,000 | |

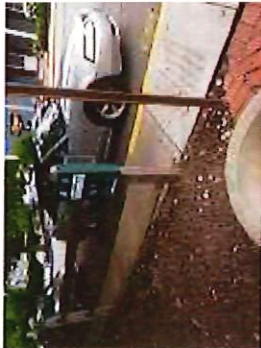
| Location | Solution / Description and Recommendation | Priority | Cost Estimate | | |
|---|---|---|---|--|--|
| <b><i>Lower/relocate dog waste bag dispenser</i></b> | | | | | |
| | The dog waste bag dispensers are mounted on posts throughout the park. The units are set back from the main park path in grass, outside of the reach range on the accessible route. | Priority 2 -<br>Serious | \$400 | | |

| Location | Solution / Description and Recommendation | Priority | Cost Estimate | | |
|---|---|---|---|--|--|
| | Relocate the dog waste bag dispensers to within the reach range of the accessible route. Lower the dog waste bag dispenser on the post. The outlet for the dispenser should not exceed an unobstructed reach of 48 inches above the ground surface. If an obstructed reach over the trash receptacle is necessary, the outlet should not exceed 44 inches above the ground surface with a maximum depth of 25 inches. | | | | |
| | Reference: ADA 308 | | | | |

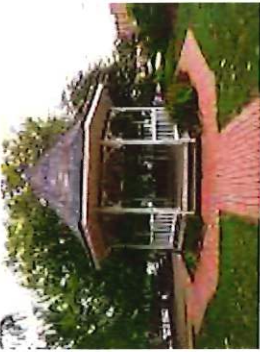
| Location | Solution / Description and Recommendation | Priority | Cost Estimate |
|---|---|---|---|
| | <b><i>Install/extend accessible route</i></b> | | |
| | There is no accessible route to enter the gazebo. There is up to a 23 inch change in elevation from the park path to the gazebo. | Priority 1 - Critical | \$4,000 |

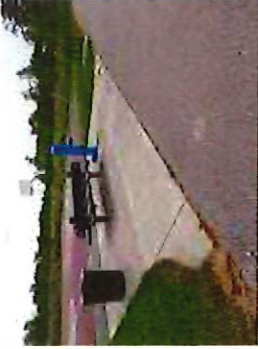
| Location | Solution / Description and Recommendation | Priority | Cost Estimate |
|---|---|---|---|
| <b><i>Provide accessible route to sports field/court</i></b> | | Priority 2 -<br>Serious | \$200 |
| | <p>There is up to a 9.8% running slope at the concrete surface perpendicular to the drinking fountain at the transition from the asphalt park path. The accessible route may be considered on the north side of the fixed bench, however it was obstructed by a trash receptacle at the time of the assessment.</p> <p>Provide an accessible route to the basketball court. Relocate the trash receptacle adjacent to the park path so the north side of the fixed bench can serve as the accessible route to the basketball court. When the concrete is altered, resurface the area not to exceed a running slope of 5% and a cross slope of 2.08%. The clear ground space at the drinking fountains and serving the wheelchair seating locations adjacent to the bench should not exceed a slope of 2.08% in all directions.</p> <p>Reference: ADA 206, 221.2.1.4, 402</p> <p>Photo: MulberryFields-017</p> <p>Record #: 61</p> <p>Cost Note: Estimate to move trash receptacle.</p> | | |

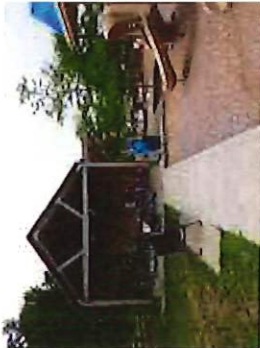
Picnic Shelter at Restroom Building

***Configure picnic area for clear floor space around picnic tables***

There are 3 standard and 1 accessible picnic tables serving the picnic shelter.

Replace 1 of the standard picnic tables with an accessible unit and design a floor plan for the picnic shelter with placement of picnic tables. Configure the picnic area so that at least 20 percent, but not less than two accessible picnic tables have space for wheelchair seating at least 30 inches wide with knee clearance and a minimum 36 inch clear width around all usable sides of the table measured from the back edge of the bench.

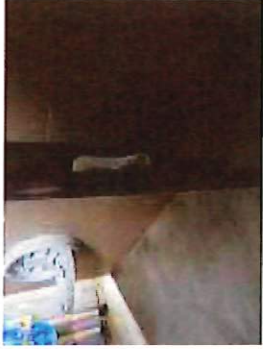
| Location | Solution / Description and Recommendation | Priority | Cost Estimate |
|---|---|---|---|
| | <b><i>Install door pull for toilet compartment</i></b><br>The accessible toilet stall door lacks a door pull on the interior and exterior.<br><br>Install a door pull on the interior and exterior. A door pull shall be placed on both sides of the door near the latch. Handles, pulls, latches, locks, and other operable parts on doors shall be operable with one hand and shall not require tight grasping, pinching, or twisting of the wrist. The force required to activate operable parts shall not exceed 5 lbs. The loop pull handle shall be installed 34 inches minimum to 48 inches maximum above the finish floor. | Priority 3 - Moderate | \$60 |

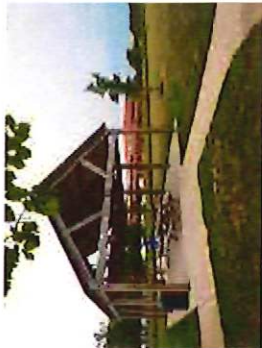
| Mulberry Fields - Picnic Shelter South of Circle Drive | | Location | Solution / Description and Recommendation | Priority | Cost Estimate |
|---|---|---|---|---|---|
| | <b><i>Configure picnic area for clear floor space around picnic tables</i></b> | | | | |
| | There is 1 standard and 2 accessible picnic tables serving the picnic shelter. | | | | |

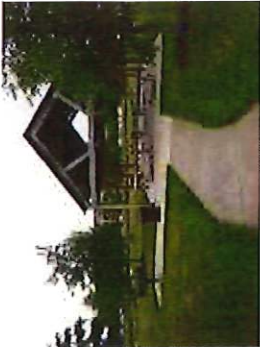
| Mulberry Fields - Picnic Shelter West of Splash Pad | | Location | Solution / Description and Recommendation | Priority | Cost Estimate |
|---|---|---|---|---|---|
| | <b><i>Configure picnic area for clear floor space around picnic tables</i></b> | | | | |
| | There are 4 standard and 1 accessible picnic tables serving the picnic shelter. Replace 1 of the standard picnic tables with an accessible unit and design a floor plan for the picnic shelter with placement of picnic tables. Configure the picnic area so that at least 20 percent, but not less than two accessible picnic tables have space for wheelchair seating at least 30 inches wide with knee clearance and a minimum 36 inch clear width around all usable sides of the table measured from the back edge of the bench. | | | Priority 2 - Serious | \$1,150 |

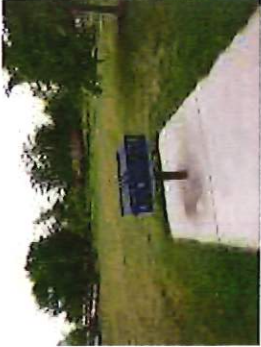
| Mulberry Fields - Picnic Shelter West of Splash Pad | | Location | Solution / Description and Recommendation | Priority | Cost Estimate |
|---|---|---|---|---|---|
| | <b><i>Provide accessible fire ring/grill</i></b> | | | | |
| | The double pedestal grill is mounted in concrete. The clear width of the concrete from the outer edge of the grill is reduced to 15-20 inches. Extend the concrete surface area at the double pedestal grill to provide a minimum 48 x 48 inch clear ground space on all usable sides of the unit. The accessible fire ring/grill shall be installed with fire building surface 9 inches minimum from the ground, a cooking surface 15 to 34 inches maximum from the ground. | | | Priority 3 - Moderate | \$1,800 |

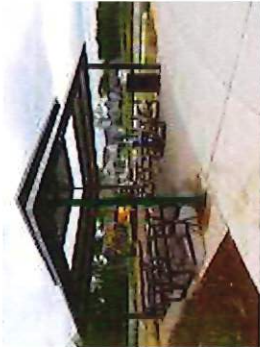
Picnic Shelter - North

**Configure picnic area for clear floor space around picnic tables**

There are 3 standard and 1 accessible picnic tables serving the picnic shelter.

Replace 1 of the standard picnic tables with an accessible unit and design a floor plan for the picnic shelter with placement of picnic tables. Configure the picnic area so that at least 20 percent, but not less than two accessible picnic tables have space for wheelchair seating at least 30 inches wide with knee clearance and a minimum 36 inch clear width around all usable sides of the table measured from the back edge of the bench.

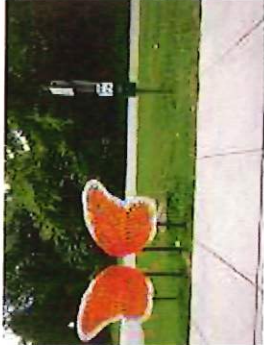
| Location | Solution / Description and Recommendation | Priority | Cost Estimate |
|---|---|---|---|
| <b>Lower/relocate dog waste bag dispenser</b> | | | |
| | The dog waste bag dispenser is mounted on the sign post. The outlet for the dog waste bag dispenser is greater than 48 inches above the ground surface and located in grass, outside of the reach range on the accessible route. | Priority 2 -<br>Serious | \$200 |

| Location | Solution / Description and Recommendation | Priority | Cost Estimate |
|---|---|---|---|
| | Relocate the dog waste bag dispenser to within the reach range of the accessible route. Lower the dog waste bag dispenser on the post. The outlet for the dispenser should not exceed an unobstructed reach of 48 inches above the ground surface. If an obstructed reach over the trash receptacle is necessary, the outlet should not exceed 44 inches above the ground surface with a maximum depth of 25 inches. | | |
| | Reference: ADA 308 | | |

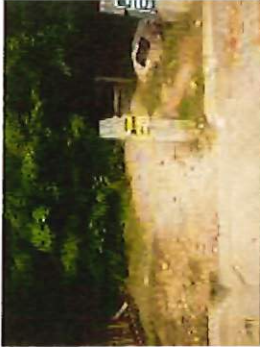
| Location | Solution / Description and Recommendation | Priority | Cost Estimate |
|---|---|---|---|
| <b><i>Provide trailhead signage with accessibility information</i></b> | | | |
| | <p>The nature sanctuary includes pedestrian trails. There is no trailhead kiosk or posted objective information on the trail characteristics.</p> <p>Provide visitor information on trailhead signage including the length of the trail or trail segment; surface type; average and minimum tread width; average and maximum running slope; and average and maximum cross slope. Utilize a design format with sans serif font, high contrast between the foreground and background colors, and font sized to the appropriate viewing distance. Consider developing a tactile map and/or model to effectively communicate locations of attractions, topography, features, and points of interest to orientate visitors with visual or cognitive impairments.</p> <p>Reference: ADA Program Access 35.149; ABAS 1017.10</p> <p>Photo: ZionNatureSanctuary-003</p> <p>Record #: 127</p> <p>Cost Note: Estimate to install trailhead sign with map and trail characteristics.</p> | Priority 1 - Critical | \$5,000 |

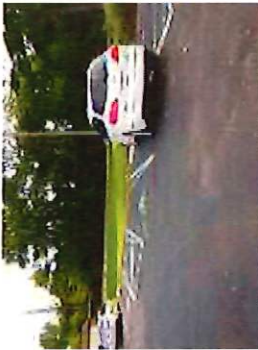
| Location | Solution / Description and Recommendation | Priority | Cost Estimate |
|---|---|---|---|
| | <b>Restripe existing parking lot to include accessible parking spaces and access aisles</b> | Priority 2 - Serious | \$2,700 |
| | There are 50 standard parking spaces and 3 designated accessible parking spaces. The accessible parking spaces and access aisles are angled. The first accessible parking space in the east parking row has a rounded access aisle that does not extend the entire length of the parking space. The accessible parking spaces lack signs. | | |

| Location | Solution / Description and Recommendation | Priority | Cost Estimate |
|---|---|---|---|
| | Stripe the access aisle to extend the full length of the parking space. Restripe for a minimum of one van accessible parking space (132 inches wide), 2 car accessible parking spaces (96 inches wide) and access aisles (60 inches wide). Alternatively, all accessible parking spaces could be striped as universal with 96 inch width for each accessible space and 96 inch width for each access aisle. Install signs designating the accessible parking spaces including the International Symbol of Accessibility. Signs identifying van parking spaces shall contain the designation "van accessible." Signs shall be 60 inches minimum above the finish floor or ground surface measured to the bottom of the sign. | | |

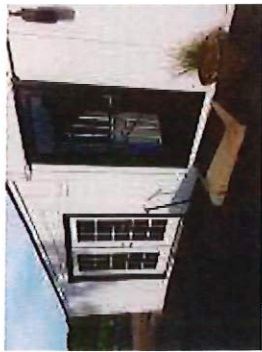
| Location | Solution / Description and Recommendation | Priority | Cost Estimate |
|---|---|---|---|
| <b>Evaluate alternative for program access</b> | | | |
| | There is no accessible entrance to the building that serves as the clubhouse and pro shop. There is up to a 9 inch change in elevation at the door on the east side of the building and up to 3 inches at the double doors to the meeting space. At the building interior, there are 2 steps down (10 inches total) to enter the lower level meeting/dining space for the 10th Hole. On the west side of the building exterior, there is up to a 3 inch change in elevation at the door. There are no accessible restrooms. | Priority 1 - Critical | \$28,000 |

| Location | Solution / Description and Recommendation | Priority | Cost Estimate |
|---|---|---|---|
| | Provide an accessible space to offer the programs, services, and activities that are conducted in the clubhouse and pro shop. In the interim, post public information that there is no accessible route into the building and the method to contact staff within the building to gain access to the programs, services, and activities. The installation of a video phone/intercom on the building exterior could help to facilitate access for people with mobility impairments who would like to pay for greens fees. | | |
| | Evaluate the remaining life cycle for the building that serves as the clubhouse and pro shop. Provide access to 60% of the public entrances. It may be most efficient to provide accessible entrances on the east side of the building in order to enter the pro shop level and the lower level meeting/dining space for the 10th Hole. | | |

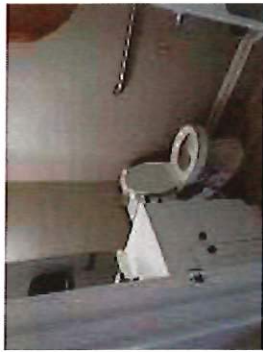
| Location | Solution / Description and Recommendation | Priority | Cost Estimate |
|---|---|---|---|
| | There are no accessible restrooms serving the clubhouse and pro shop. The current single user men's and women's restrooms were recently renovated to include new flooring, base cabinets, lavatories, toilets, and dispensers. The alterations did not include accessibility improvements. The clear width at the doors for each single user restroom is reduced to 22 inches. The single user restrooms lack the minimum clear floor space at fixtures and turning space within the room. The current dimensions are 51 1/2 x 57 1/2. | Priority 1 - Critical | \$18,000 |

| Location | Solution / Description and Recommendation | Priority | Cost Estimate |
|---|---|---|---|
| | Provide accessible restrooms serving the clubhouse and pro shop. | | |

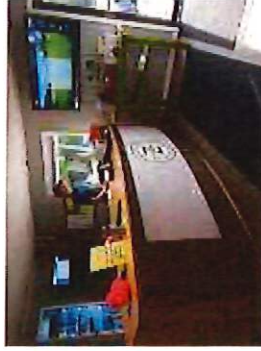
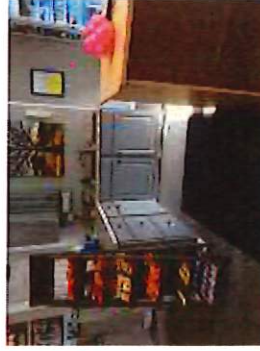
| Location | Solution / Description and Recommendation | Priority | Cost Estimate |
|---|---|---|---|
| | The shelf for the video/cable box and the wall mounted monitor protrude 5-10 inches from the wall potentially resulting in a hazard for people with visual impairments. | | |

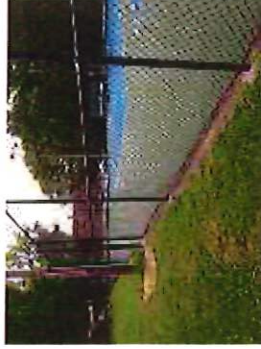
Record #: 56

Priority 1 -  
Critical  
\$18,000

Cost Note: Estimate for concrete path 250 ft x 5 ft.

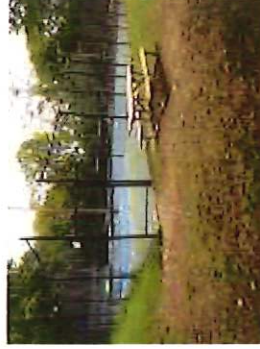
Record #: 58

Priority 1 -  
Critical  
\$6,500

Cost Note: Estimate for open space picnic area with 2 accessible tables, new asphalt path 30 ft x 6 ft.
